Historic Preservation Plan for the Chestnut Street Cemetery Apalachicola, Florida

for the Apalachicola Area Historical Society, Inc.
and City of Apalachicola, Florida

Final Version, June 2016

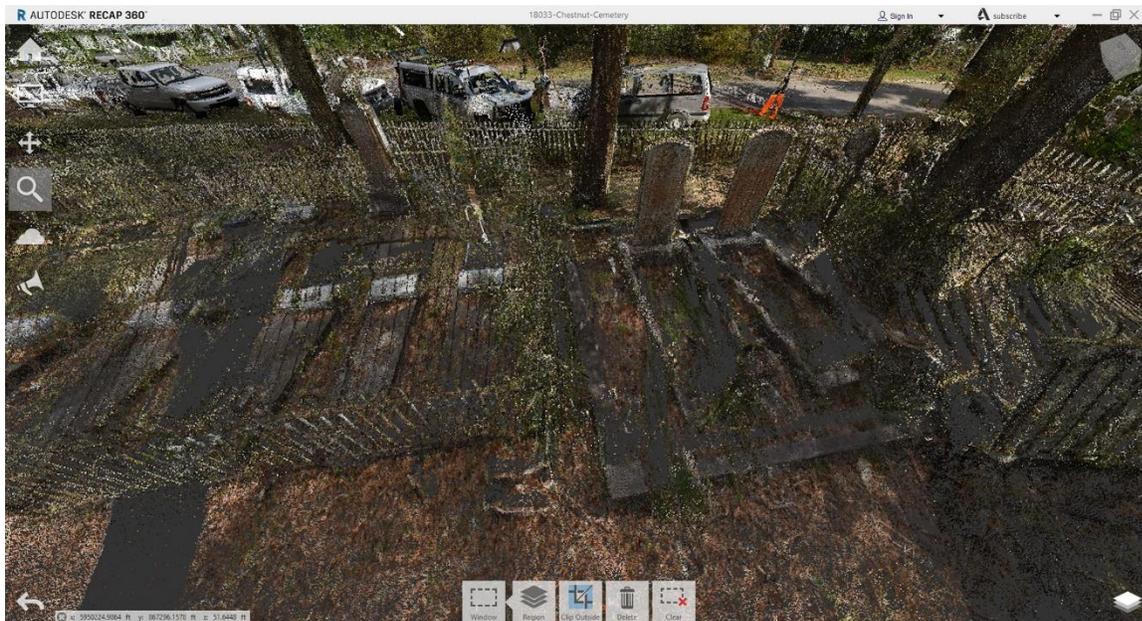
The image above shows a view of the north corner of the cemetery, where Avenue F intersects the alley on the right. The perimeter fence is visible along two sides. The view appears as though it were taken from above, although the survey instrument was always on a tripod about 6 feet above the ground. This view to the north shows the Asher, Menke and Witherspoon Lots, along with the adjacent unnamed lot where the wood fence has collapsed. While this is a static view, scans were collected from a number of instrument positions, so each scene can be viewed from any direction to show the same objects from the any side or angle.

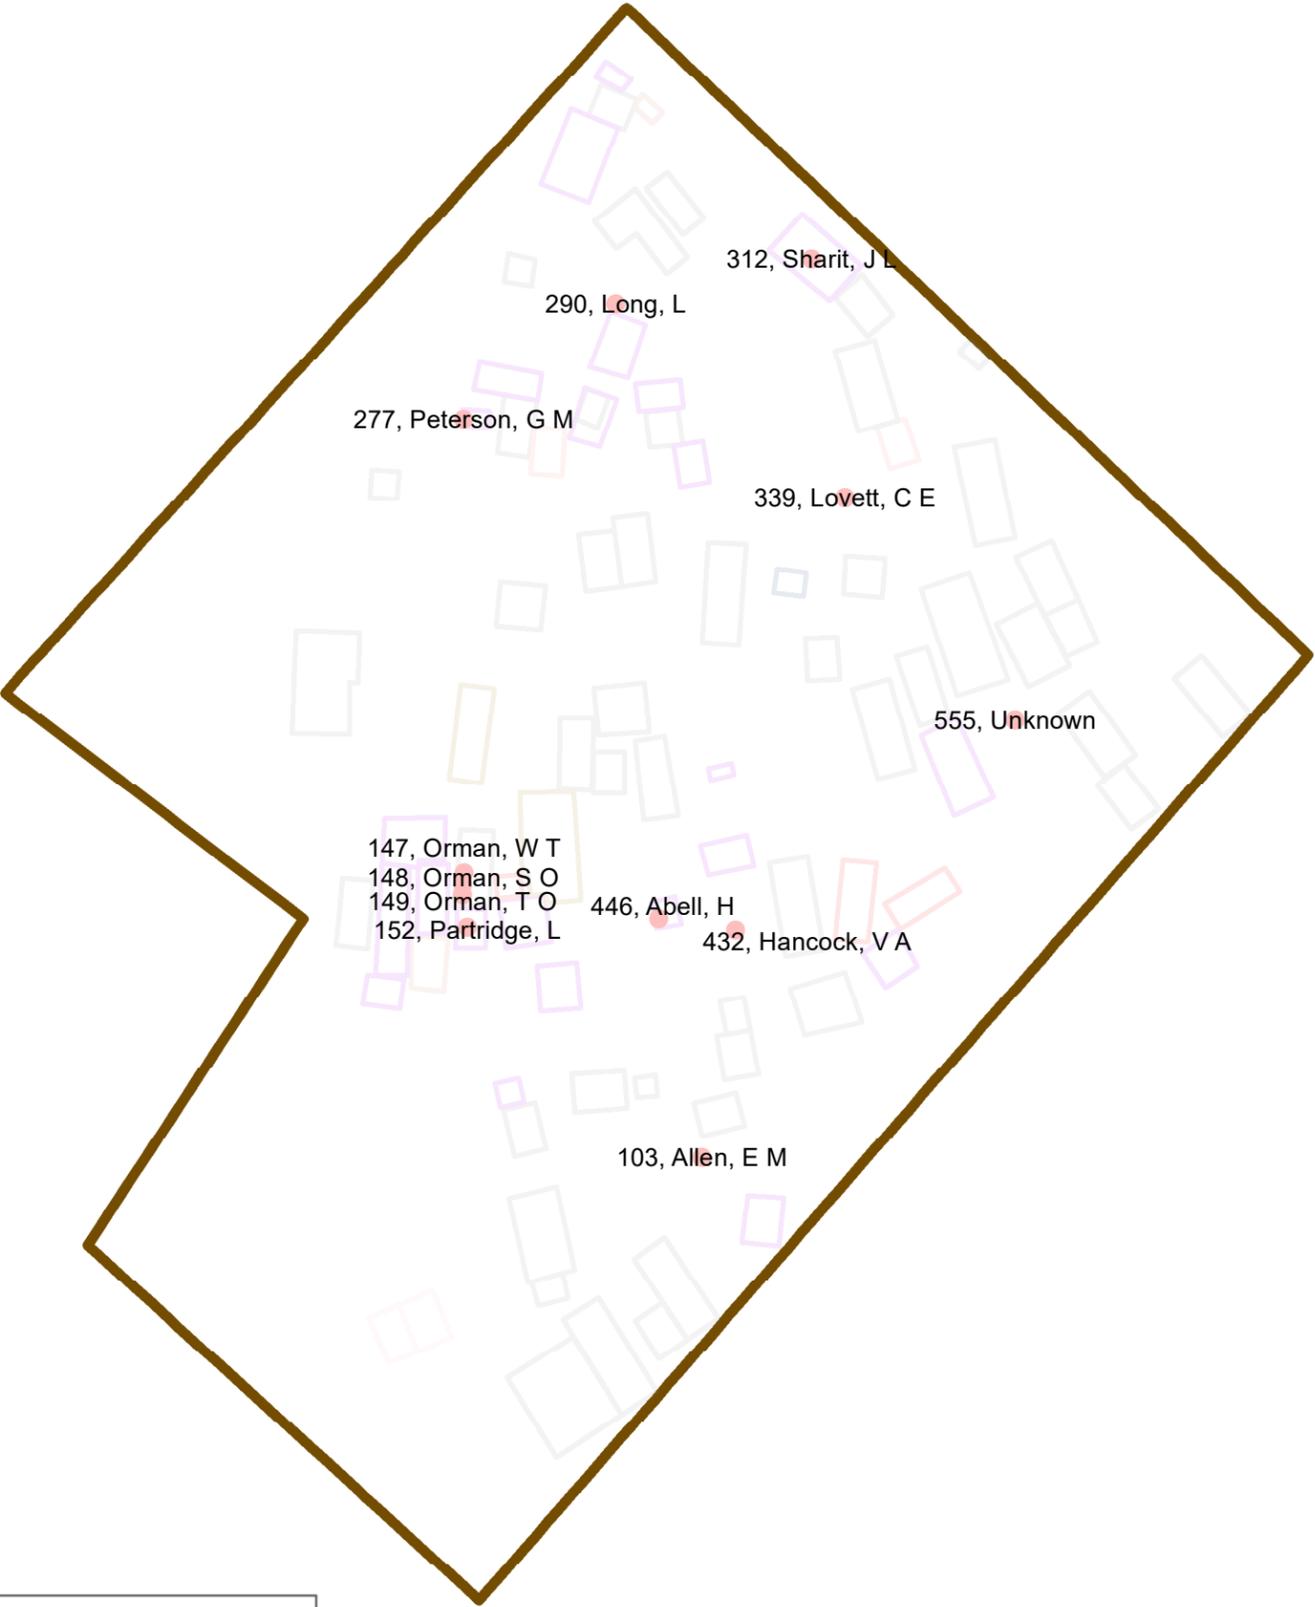
Map Number	Name	Condition
103	Elizabeth M. Allen	Leaning monument
147	W. T. Orman	Leaning monument
148	Sarah Orman	Leaning monument
149	Thomas Orman	Leaning monument
152	Partridge Family Monument	Leaning monument
277	Gustave M. Peterson	Leaning monument
290	Louis Long	Base is severely tilted
339	Catherine Ella Lovett	Headstone leaning precariously on footstone
432	Virginia Hancock	Leaning monument
446	Hattie Abell	Leaning obelisk
555	Unknown Burial	Vault is cracked and could collapse
	Dead Tree	Dead limbs overhead are hazardous

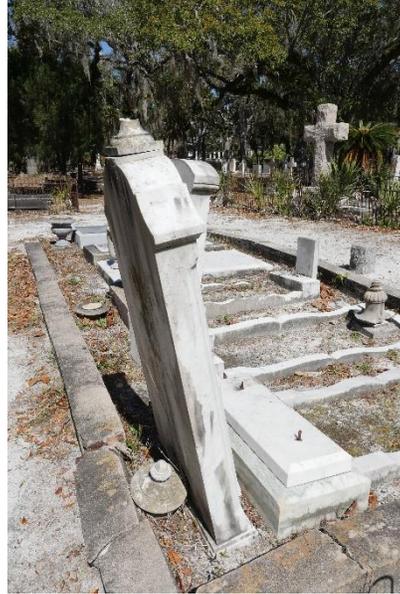
This lot needs immediate attention due to the precarious condition of the large tablet at the grave of Thomas Orman (#149). **A slight shift in the position of the fragment of concrete curbing will topple the heavy tablet. It is recommended that this area be secured with yellow CAUTION tape immediately and that the tablet be removed or braced as soon as possible.** This condition should be evaluated by an experienced specialist with proper equipment and knowledge. If necessary, perhaps the tablet could be placed temporarily on elevated supports within the grave cradle with lettering down and with enough height to not touch the marble cradle pieces. Or it may be possible to replace and reattach the tablet safely to its base.

The two adjacent monuments, of Sarah Orman (#148) and W.T. Orman (#147) are also in a precarious state, and should be addressed at the same time. The base and tablet of the monument for Sarah lean forward severely, and are at risk from further settling or any lateral force. **The monument of W.T. Orman should also be evaluated for repair and stabilization.** The other monuments are intact and stable and need no immediate attention.

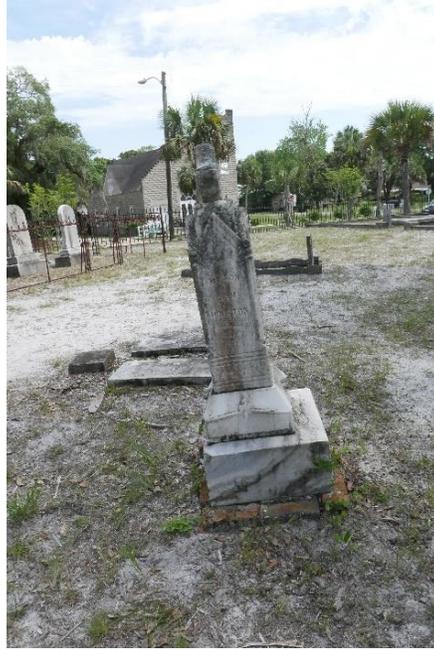
Monument of Elizabeth M. Allen (#103)

This grave requires immediate attention. It is marked by an ornate marble obelisk that is badly tilted and a hazard to both persons and the monument. **It is recommended that the surrounding area be secured by yellow CAUTION tape until the leaning monument can be stabilized.** The condition should be evaluated by an experienced specialist with proper equipment and knowledge to advise and carry out necessary work safely. A makeshift solution would be to remove the obelisk and base and store them on supports, off of the soil and with lettering down. Do nothing else at this grave until this dangerous condition has been addressed.

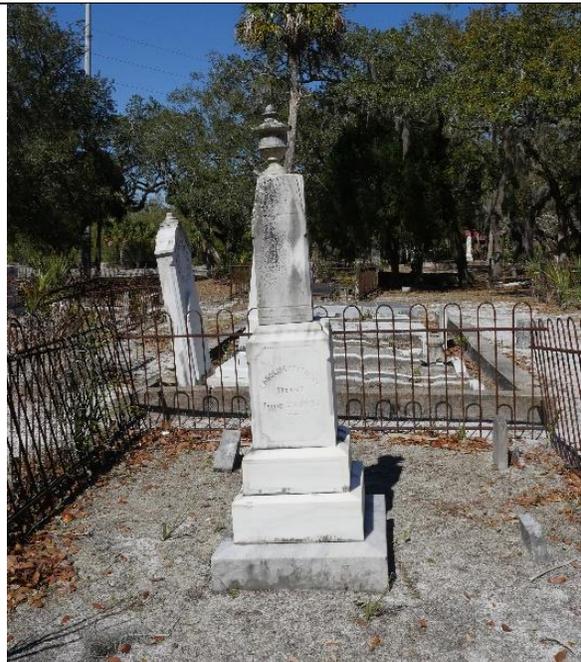
Monument of Gustave M. Peterson (#277)

Located in the Peterson lot, the monument is leaning precariously. The ground has eroded and sloughed or settled to the west, undermining the monument base and putting the entire monument at high risk of falling. **A heavy urn that previously stood at the top of the monument has already toppled** and is standing on the ground outside the fence. On the east and north sides, the brick foundation of the monument is exposed, revealing the severity of settling. Three of the five monument components are not firmly attached and have already shifted.

It is recommended that the area be secured with yellow CAUTION tape as soon as possible. If it is not possible to address the monument foundation quickly, arrange for the three remaining monument pieces to be removed with proper lifting equipment and experienced help. Set the monument pieces adjacent to the foundation inside the fence. Use supports to keep the monument off the ground, and ensure the lettering faces downward so that rainwater does not collect in the face of the monument.

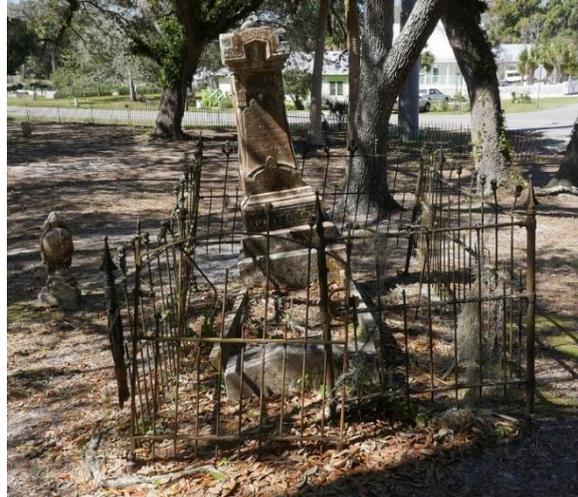
There is an urn base at top of the standing monument which likely does not belong there; the decorative urn now on the ground beyond the west side of the lot appears to be the proper top element.

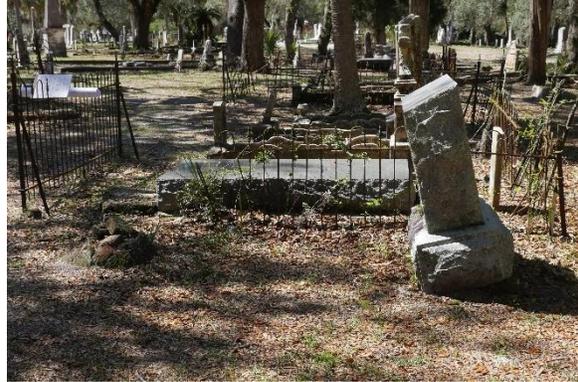
Monument of Louis Long (#290)

This monument is a hazard. It should be marked with yellow CAUTION tape until it can be properly evaluated and treated. The grave is marked by a large granite upright on a thick granite base. The entire monument is tilted far to south toward monument front. It rests on a brick foundation which is also tilted. The upright has not shifted on the base, but the tilt is severe and the upright is at risk of falling with additional settling of foundation or some lateral force.

This monument may not appear to present an immediate danger, however, due to its large size and great weight, **it represents a serious risk if it should topple.** The monument and foundation should be evaluated as soon as possible by a qualified and experienced specialist as to the adequacy of the foundation and the proper means of resetting the monument and alleviating the risk

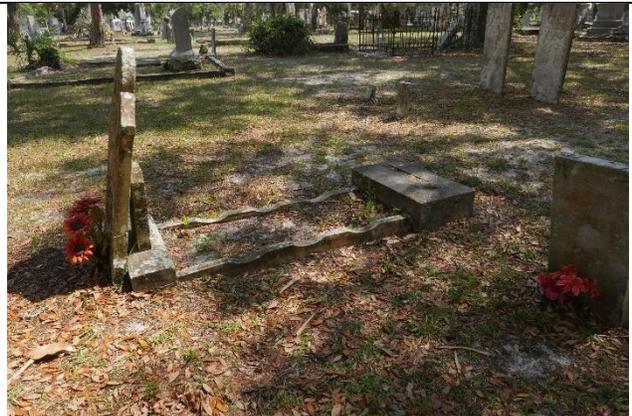
Monument of Catherine Ella Lovett (#339)

This grave requires immediate attention. The marble tablet headstone is leaning against the footstone in a precarious arrangement. A slight pressure could snap the footstone and allow both the footstone and tablet to fall into the marble grave border. There is a risk to anyone nearby and a risk to the monument. **It is recommended that the area be secured by yellow CAUTION tape until the leaning monument can be stabilized.** A temporary solution would be to remove and store the headstone on supports off the ground and with the lettering facing downward. The headstone should be placed so that previous cracks in the headstone run across, rather than parallel to, the supports. Do nothing else at this grave until this dangerous condition has been addressed.

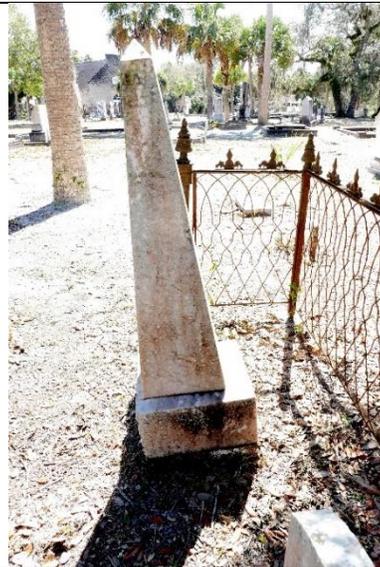
Monument of Hattie Abell (#446)

Located in the Abell Lot, the leaning obelisk is a hazard. **It is recommended that the gate opening be closed immediately with yellow CAUTION tape until this condition can be addressed.** If the monument cannot be repaired soon, the obelisk should be removed and placed flat on the ground on supports to keep it out of the dirt. Resetting will involve repair and stabilization of the brick and mortar foundation; this should be evaluated and completed by a specialist experienced with such conditions. This should be done before any other work is done in the lot.

- **The leaning obelisk of Hattie (#446) is a hazard.** It is recommended that the gate opening be closed immediately with yellow CAUTION tape until this condition can be addressed. If the monument cannot be repaired soon, the obelisk should be removed and placed flat on the ground on some supports to keep it out of the dirt. Resetting will involve repair and stabilization of the brick and mortar foundation; this should be evaluated and completed by a specialist experienced with such conditions. This should be done before any other work is done in the lot.
- When the obelisk is stable, remove all nuisance vegetation from the fence consistent with the vegetation standards.

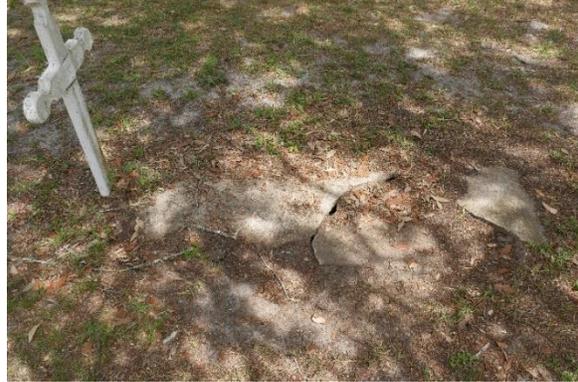
Unknown Grave (#555)

This grave requires immediate attention. The top of what appears to be a barrel vault is broken through in at least three places and has recently been uncovered at the south side. It is possible that a person or equipment could fall through into the grave. **It is recommended that the area be secured by yellow CAUTION tape until the broken vault can be stabilized.** This condition should be assessed by a specialist experienced in historic cemetery restoration and repair.

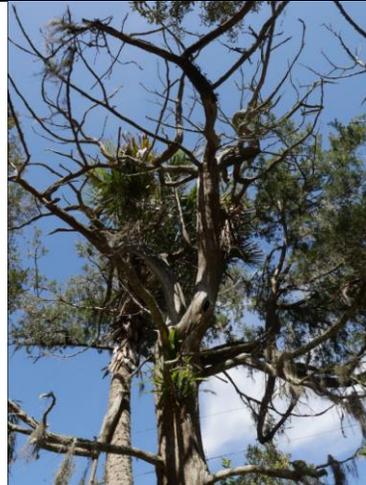
Campbell Lot 3 Tree

There is a large cedar tree at the north middle of the lot. Many parts of the tree are dead. One limb is hanging now. Dead limbs are over this lot and fence as well as over the adjacent fragile marble tablet markers to the north. **Take care of this early.** Make sure it is addressed in the arborist's evaluation of all trees in the cemetery.

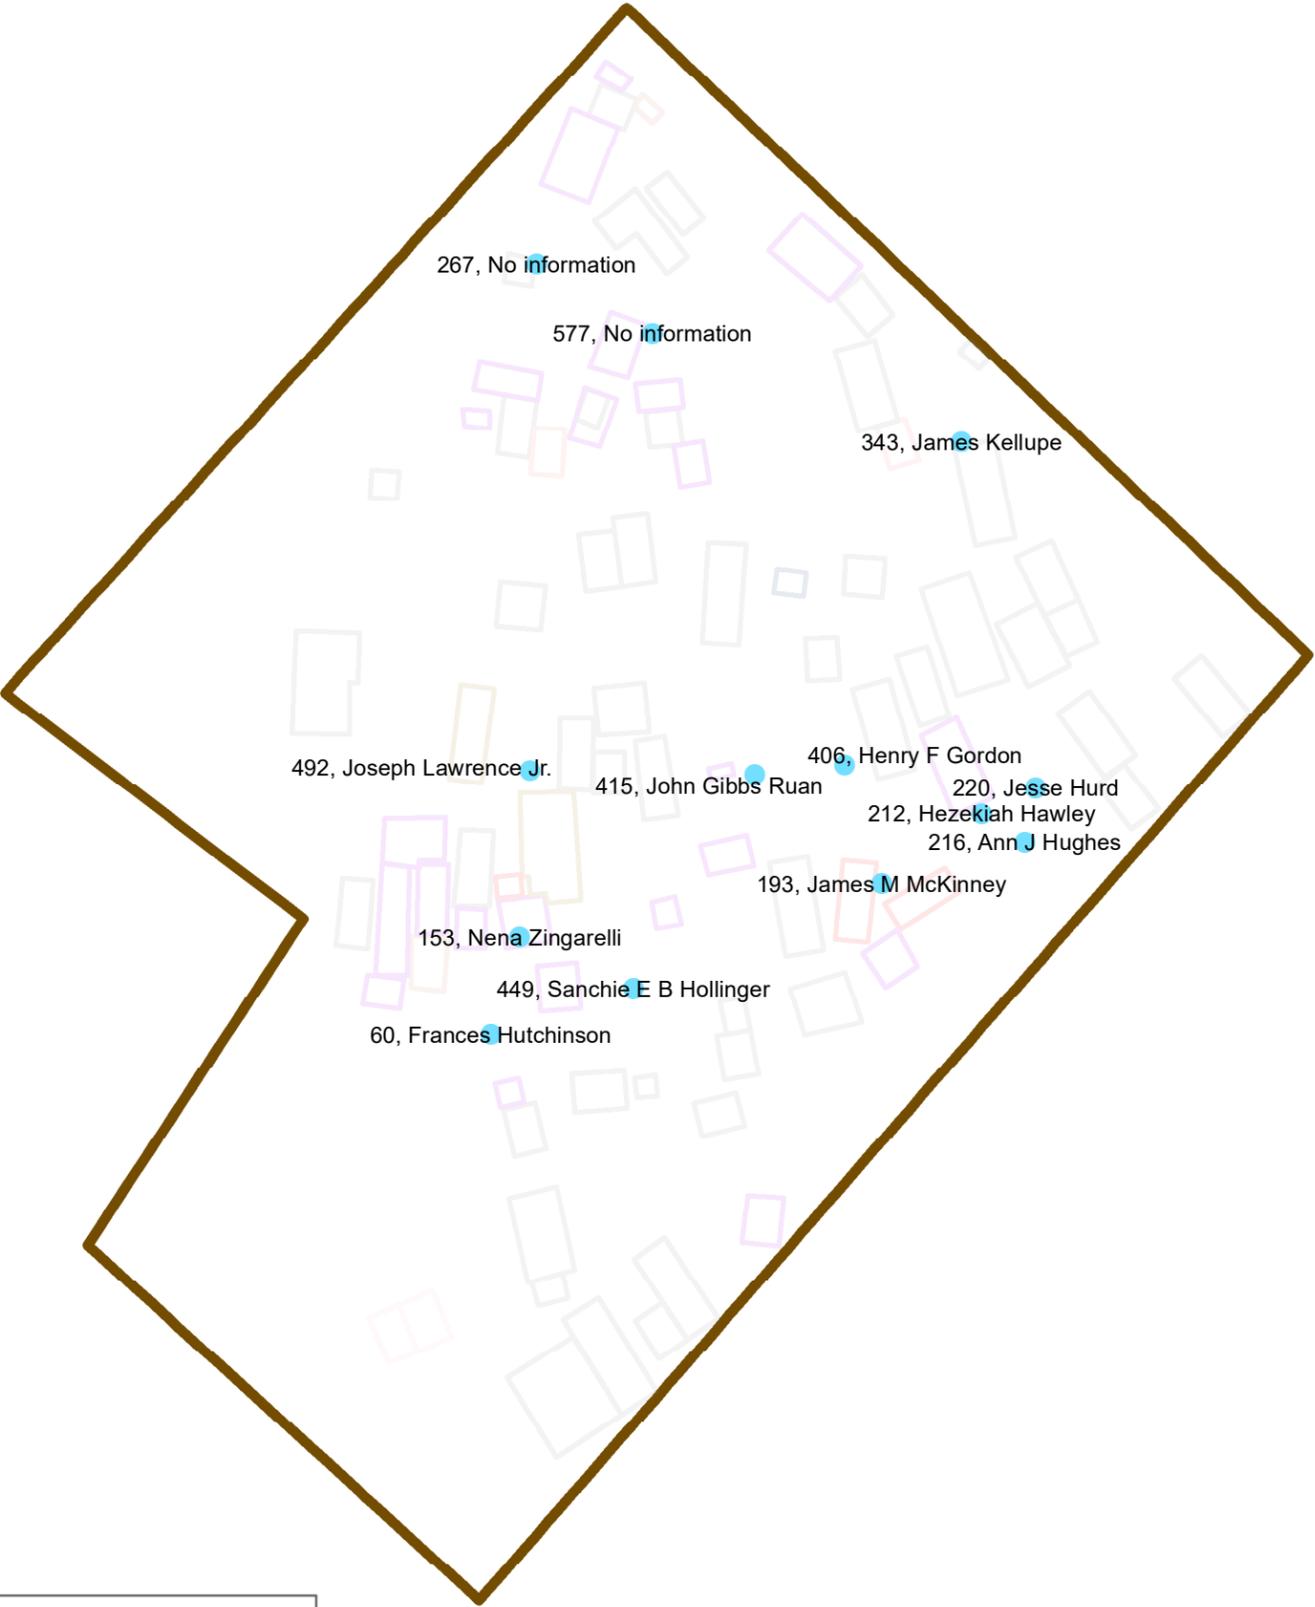
Priorities for Repair
 Chestnut Street Cemetery
 Historic Preservation Plan

Map Number	Name	Condition
60	Frances Hutchinson	Monument is tilted and the tablet is loose in its base
153	Nena Zingarelli	Cross is not attached at top of monument and should be placed in grave until repair is possible.
193	James M. McKinney	Ledger badly displaced
212	Hezekiah Hawley	Vault is badly deteriorated
216	Ann J. Hughes	Leaning monument
220	Jesse Hurd	The footstone of Samuel S. Johnson (#106) was relocated to this grave
343	James Kellupe	Vault is badly deteriorated
406	Henry F. Gordon	Obelisk has been removed from base and is leaning in ground
415	John Gibbs Ruan	Leaning monument
449	Sanchie E. B. Hollinger	Leaning monument
492	Joseph Lawrence, Jr.	Leaning monument
577	Unknown Burial	The footstone of Elizabeth J. Daniel (#318) was relocated to this grave
578	Unknown Burial	Small wooden graveboard at high risk for damage

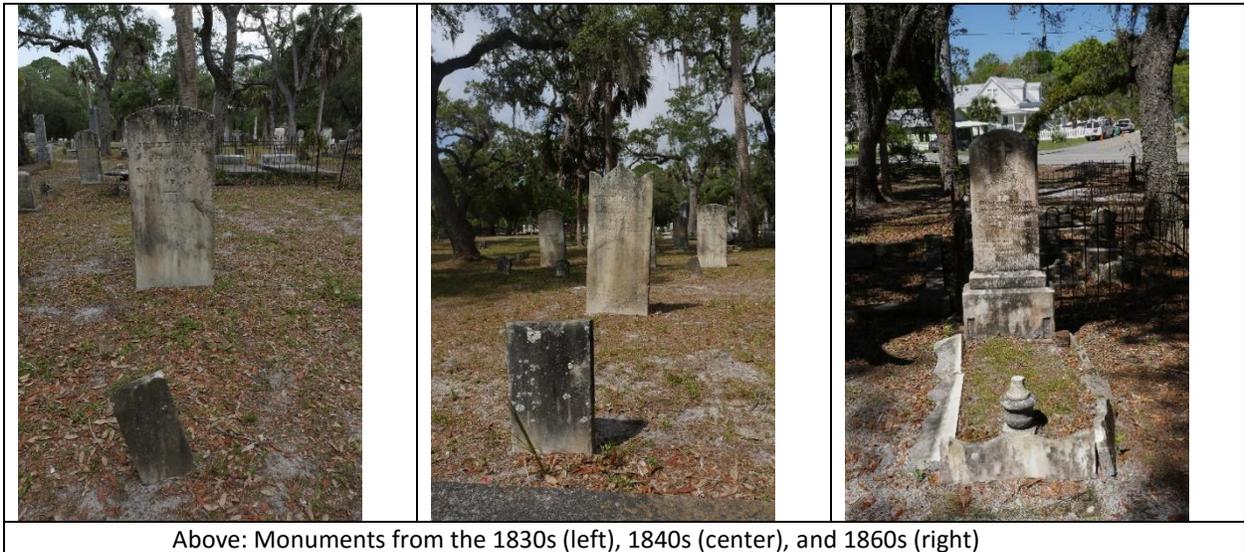
In Chestnut Street Cemetery, the older monuments of the 1830s through the 1870s generally consist of marble tablets with rounded, shouldered or crowned tops. They are generally heavily stained by biotic growth, and the inscriptions are often faded.

Above: Monuments from the 1830s (left), 1840s (center), and 1860s (right)

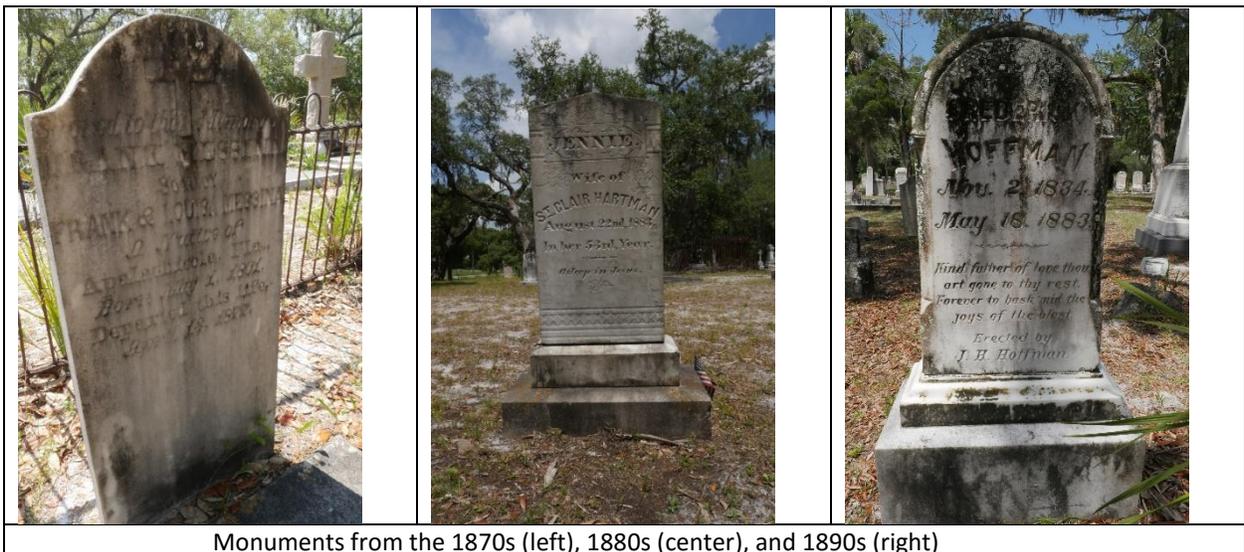
Monuments from the 1870s (left), 1880s (center), and 1890s (right)

During the 1880s, a few monuments show the influence of Eastlake style design. Obelisks also appear more frequently in the latter half of the 19th century and into the early 20th century. There are also scattered monuments associated with fraternal organizations, such as the Woodmen of the World and the Masons. Nevertheless, the same basic monument design of an upright tablet with a rounded or shouldered top remained the norm.

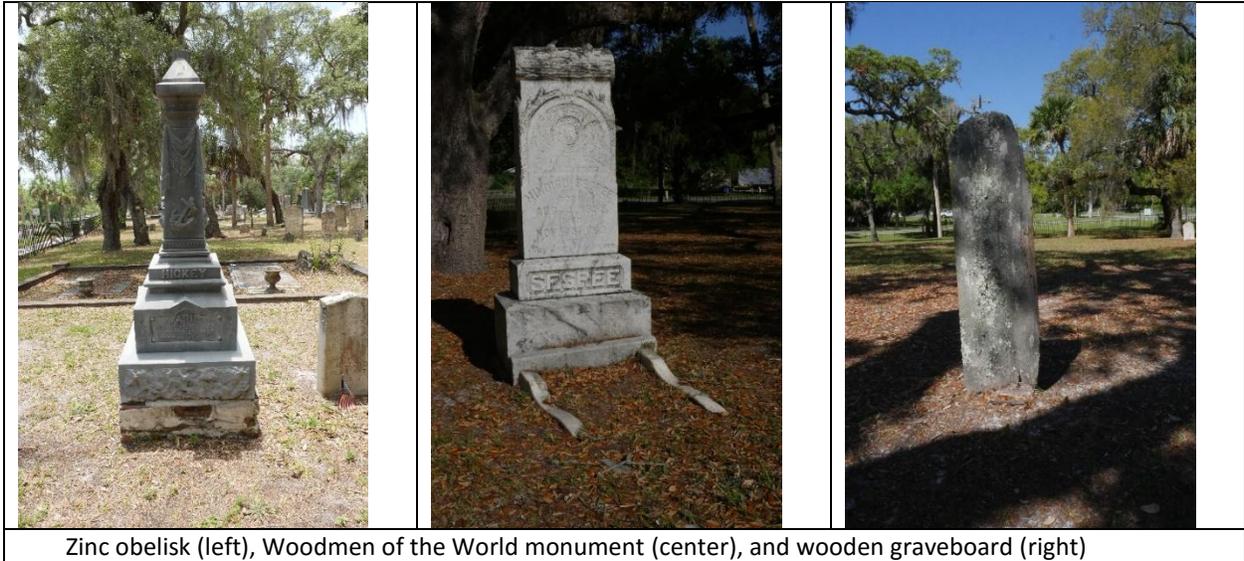
Zinc obelisk (left), Woodmen of the World monument (center), and wooden graveboard (right)

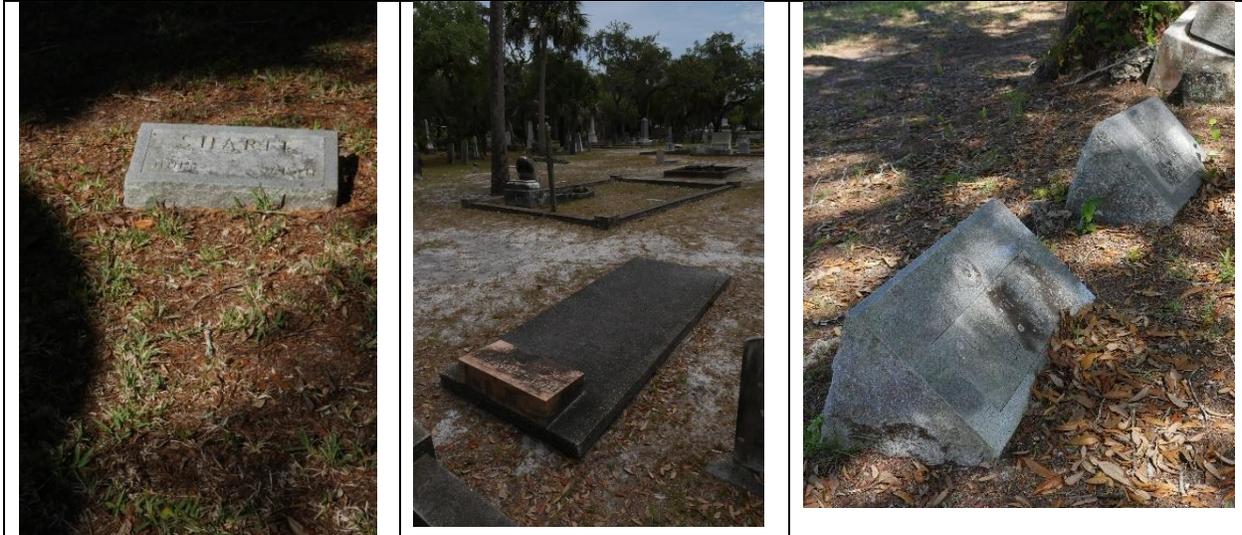
During the early 20th century and continuing to present, monuments consisting of a simple beveled, slant or flat headstones are more frequent. These are sometimes placed atop or at the head of a ledger. A common design is a granite headstone with rough-dressed stone on the sides and a polished field on top for the inscription.

Granite headstone with polished top (left),
Beveled headstone on a ledger (center), slant headstones (right)

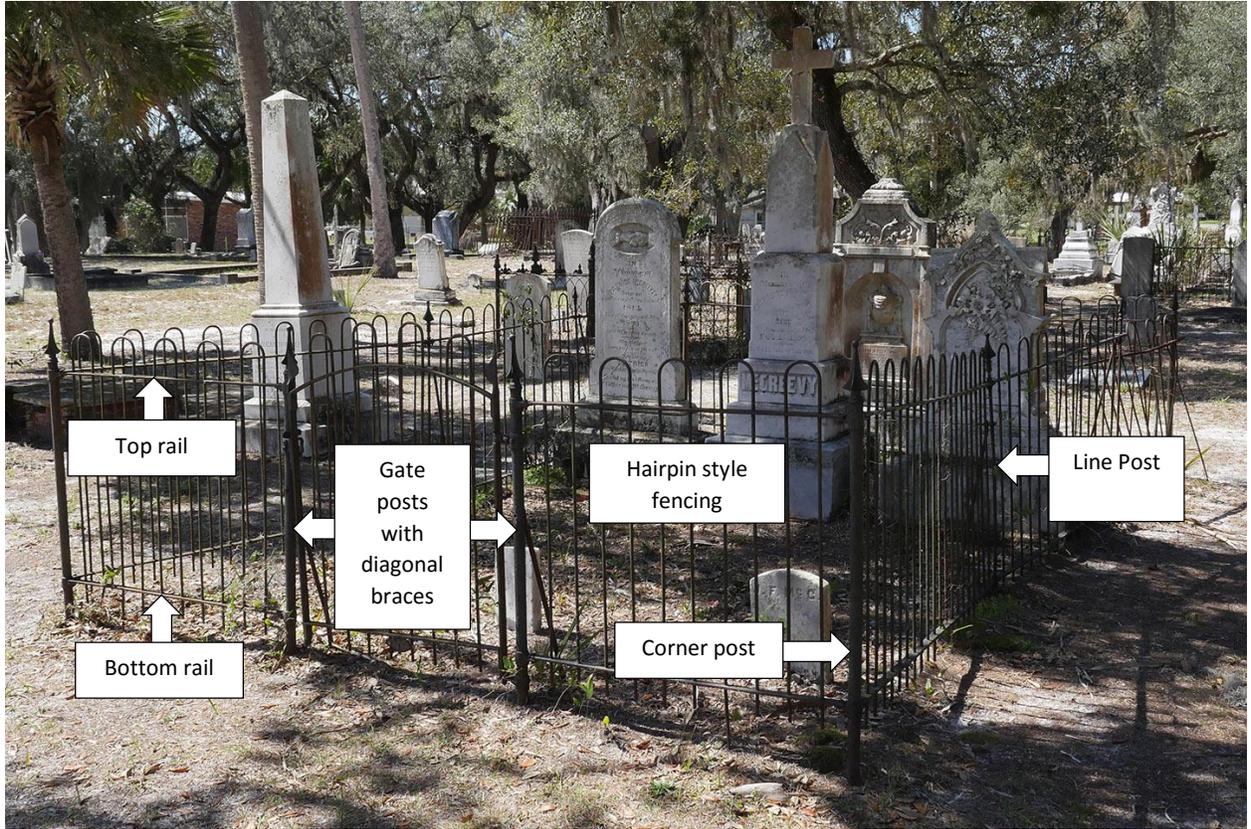
Top rail

Bottom rail

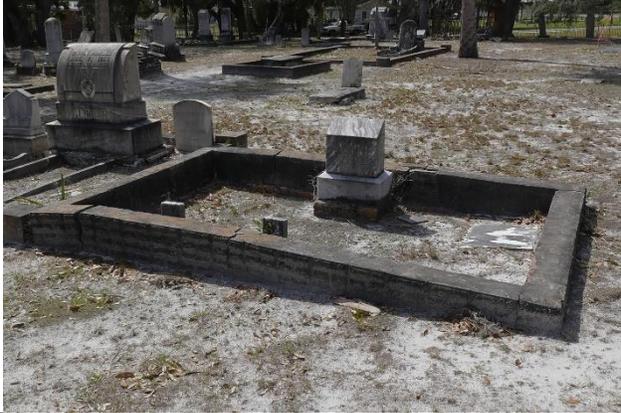
Allen Lot 2

3 possible graves were noted:

- Acquire professional advice about whether the border can be reset on a more stable foundation and put back together.
- Unless a buried base for the stone fragment on the ground next to the headstone of Nancy can be found by probing, leave the fragment where it is.
- Remove vegetation and debris from the lot in accordance with the vegetation standards.

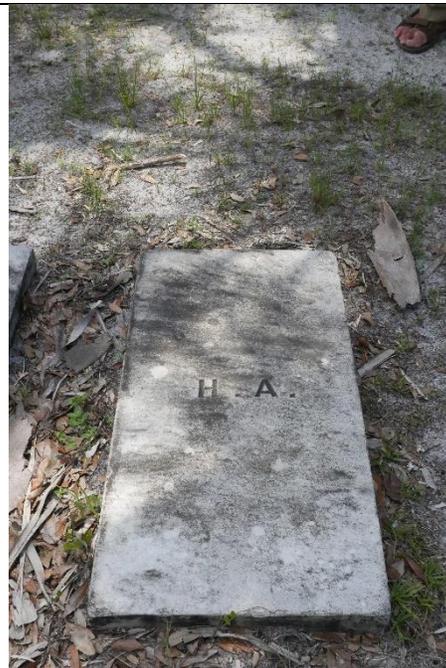
This grave is marked by a child-sized marble ledger with flat sides. There is some chipping on the corners. Although this ledger is inscribed simply "H.A.," the adjacent monument for Elizabeth M. Allen (#103) mentions "My son Henry" on the side facing this grave.

There is a concrete block with no identifying marks near the foot between this grave and the adjacent, nearly identical grave of Myrtle J. Peck (#105).

Apply the vegetation standards.

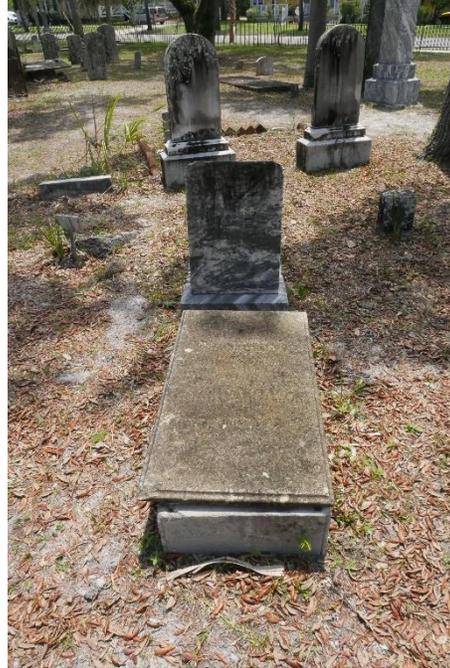
Map Number: 227

This grave is marked by a flat-topped marble CSA military marker ("Co. A. 2nd Fla. Cav."). It is plumb and level and has been recently cleaned. There are 2 chips at the rear top edge and chips from mechanical weed trimming at the base. The headstone may have broken off of its base and been reburied at this level.

Probe the soil to determine if the base of the monument remains buried. If so, consult a qualified specialist about repairing and resetting the monument. This is a low priority. Apply the vegetation standards.

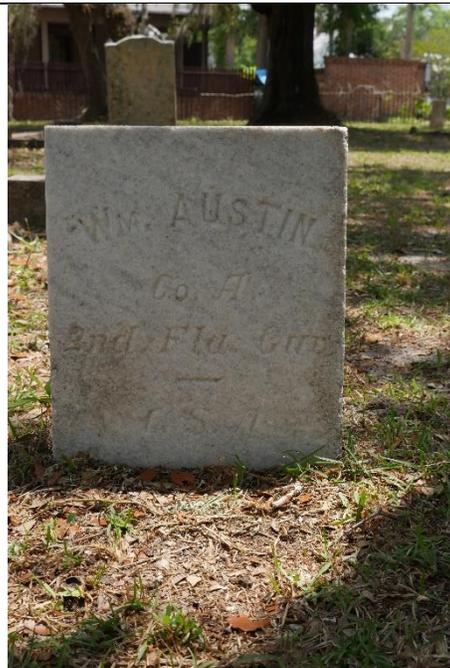
Map Number: 228

This grave is marked by a thick marble tablet inset in a beveled marble base that is almost completely buried except at the north edge. It has been recently cleaned. There is no lichen growth or discoloration, except soil staining at the base. The monument is not solidly attached to its base and leans toward the front (east) and toward the side (south). However, it does not appear to be at risk at present.

There is a round-topped footstone marked "W.H.A." which leans forward (west). It is heavily chipped on the north edge and has large spall cracks. The footstone is solid in the ground.

The headstone and footstone could be reset, but they are not at risk. Apply the vegetation standards.

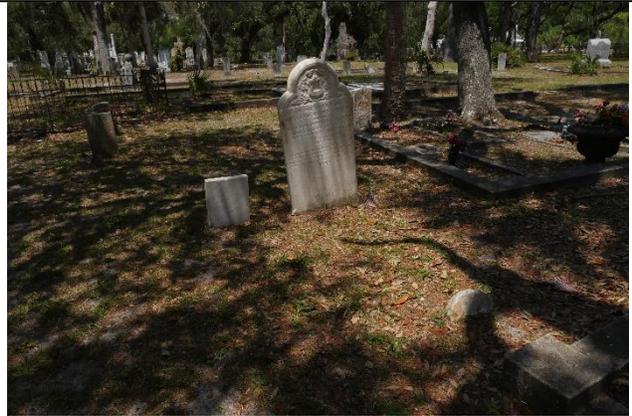
Map Number: 118

This grave is marked by an upright flat-topped marble CSA military marker ("Co. A, 2nd Fla. Cav."). It is tilted to the east and south. There is chipping at the front top of the headstone and on the north side, as well as chipping from mechanical weed trimming at the corners of the base. The top and inscription have been cleaned, but there is heavy lichen growth and biotic staining on the rear.

Straighten the monument with guidance from an experienced specialist.

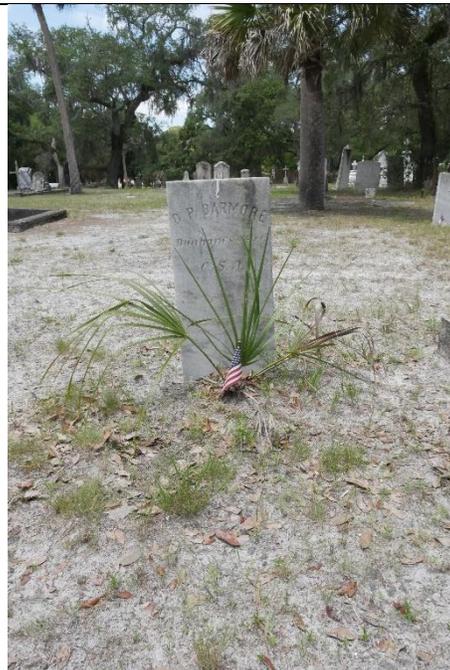
Map Number: 417

This grave is marked by a thick marble tablet headstone with a rounded top. It was previously inset with a mortise and tenon joint, but now rests against the front of its marble base. The tenon is apparently intact as it is not broken off in the mortise. The base leans to the rear so that the grave cradle sides are detached and have rotated slightly. The marble sides are stepped and the cradle foot is scalloped with a carved floral decoration at the center. The headstone is heavily discolored and the grave cradle is moderately discolored.

A cedar tree located at the southwest corner of the grave has grown around the stone base and brick and mortar foundation and displaced them. The headstone is solid, however, and not at immediate risk.

This grave should be assessed by an arborist and a qualified stone specialist working together. The monument may have to be shifted slightly as the growth of the cedar tree may prevent reassembly of the monument in its original location. In the meantime, the headstone and base should be left alone. Remove sabal palm shoots and other vegetation according to the vegetation standards.

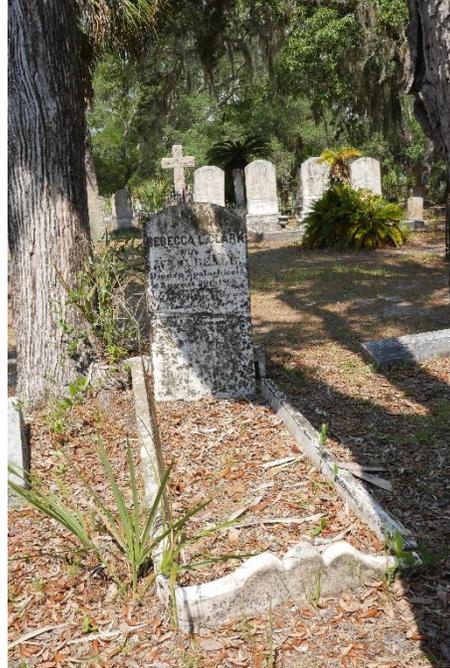
Map Number: 3

This grave is marked by a thin marble upright tablet with slightly rounded top. The tablet rests against a cinder block placed at the rear of the monument. The tablet is chipped at the lower edges from mechanical weed trimming. There is heavy lichen growth on the sides and rear, but the inscription has been cleaned. There is a marble flat-topped footstone that is tilted and the north corner is broken off. It has lichen growth and staining and no lettering is apparent.

Consult a qualified specialist to reset or otherwise ensure that the tablet is secure in the ground. As the grave of an enslaved person, this monument may also offer the potential for interpretation in relation to burial patterns reflecting race and status.

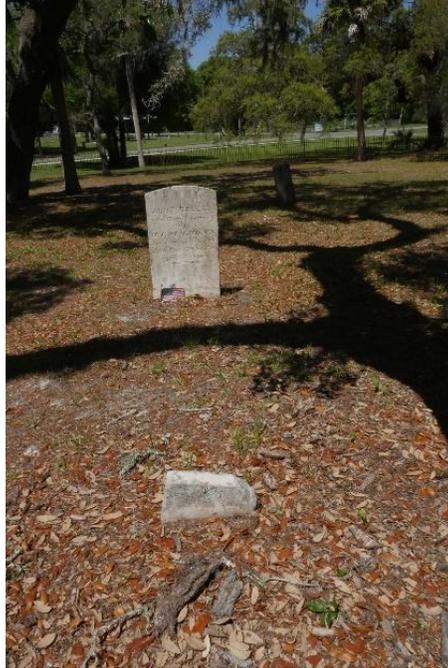
Map Number: 8

This grave is marked by a concrete round-topped tablet with incised or stamped lettering. The sides are beveled. There is a large chip at the upper edge and chipping from mechanical weed trimming at the lower edges. The monument is stable and fairly upright. There is heavy lichen growth and staining, and the surface is eroded somewhat from biotic growth.

Apply the vegetation standards.

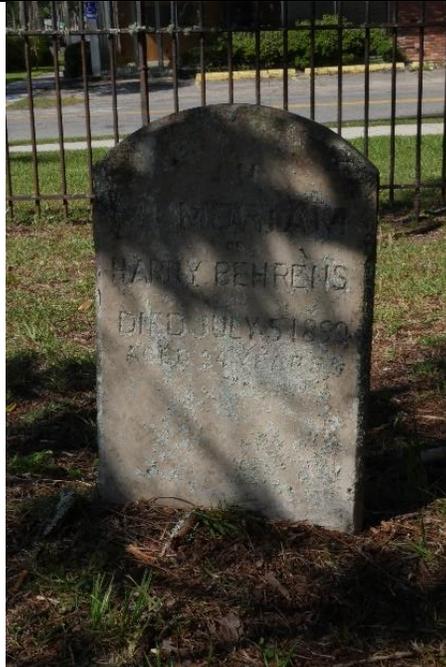
Map Number: 361

This grave is marked by a marble flat-topped CSA military marker ("Dunham's Artillery"). There are minor chips at the edges, particularly damage from mechanical weed trimming at the lower edges. There is moderate lichen growth but the inscription appears to have been cleaned. No footstone is apparent.

Apply the vegetation standards.

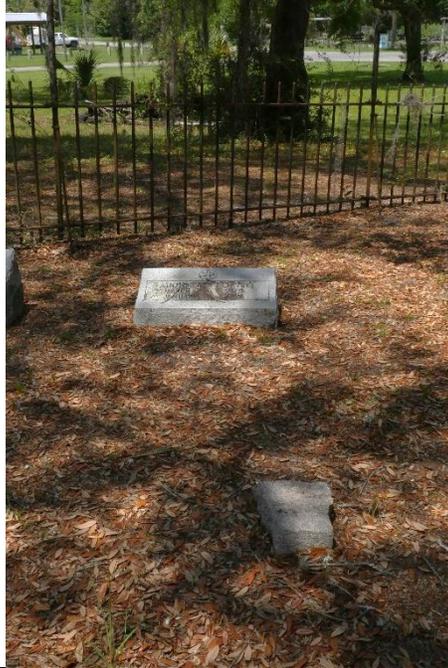
Map Number: 526

This grave is marked by a marble flat-topped tablet. It leans slightly to the rear (west), but is solid in the ground. There is black staining from biotic growth but no lichen growth. It appears to have been cleaned. There is a flat-topped marble footstone which leans to the west and south. It has some lichen growth and staining.

The tablet and the headstone may be reset to plumb and level, but this is a low priority. Apply the vegetation standard.

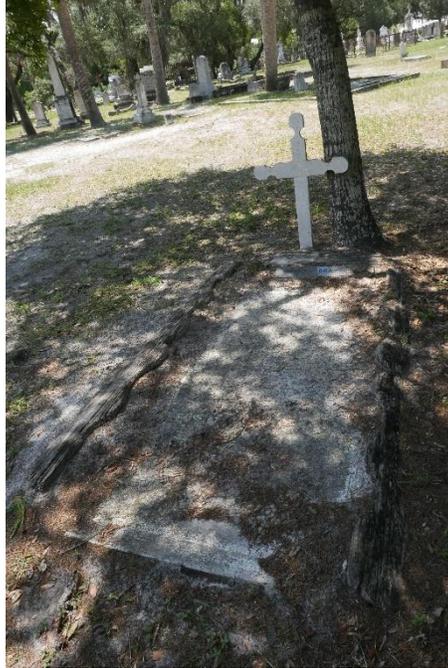
Map Number: 101

This grave is marked by a marble round-topped tablet with raised lettering at the top. It is square and level. It is cemented into what may be a red sandstone base, or a cement base that is very badly stained. There is lichen growth and some biotic staining.

Apply the vegetation standards.

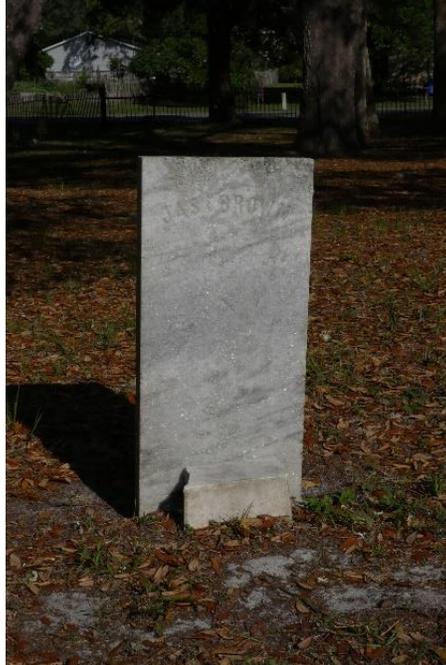
Map Number: 470

This grave is marked by a flat-topped marble CSA military marker. It is largely identical to the adjacent marker for George Brown (#469). The headstone is badly tilted forward to the north and slightly west. There is a chip at the top corner and the lower edges are chipped from mechanical weed trimming. There is heavy lichen growth and staining on all sides of the monument.

Straighten the monument with the guidance of an experienced specialist. Apply the vegetation standards.

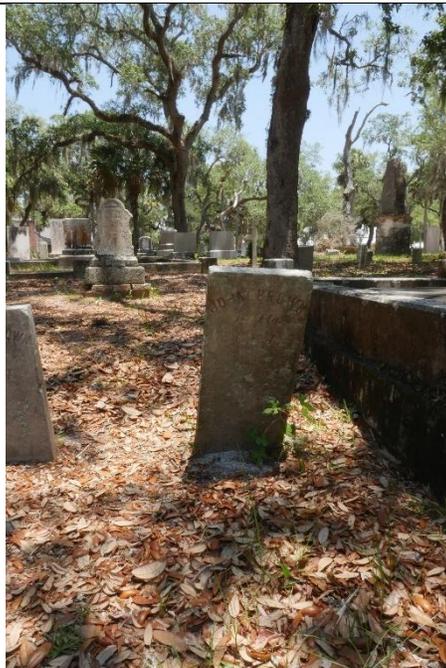
Map Number: 342

This grave is marked by a marble tablet that is nearly identical to that of the adjacent grave of H. F. Quant (#341), but it was carved with a different plant in the circle at the top. It also leans and tilts in a similar manner to the adjacent tablet headstone. It is solid in the ground. There are bedding plane cracks along the top and north edges. There is heavy lichen growth on the edges and rear, but the inscription has been cleaned.

This monument and its footstone, just as with the adjacent grave (#341), do not require any treatment. The headstone and footstones are stable, but fragile. Apply the vegetation standards.

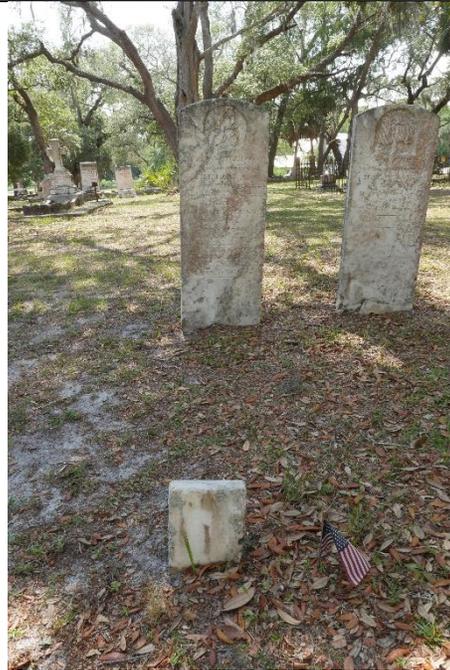
Map Number: 87

This grave is marked by a pink beveled headstone, apparently marble, at the head of a concrete ledger. Portions of the headstone are heavily stained by biotic growth but overall both headstone and ledger are in very good condition.

Apply the vegetation standards as necessary.

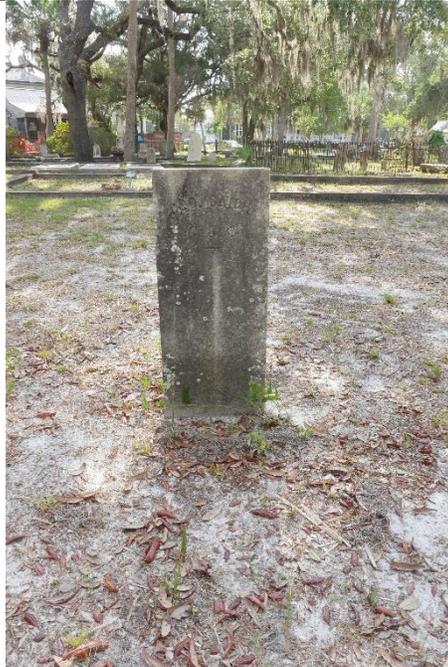
Map Number: 270

This grave is marked by a granite slant headstone with a polished face and rough-dressed sides. It has a Masonic symbol on the face, but is otherwise largely identical to the adjacent headstone of Sarah Campbell (#269). The stone has settled slightly and there is some lichen growth and biotic staining.

Apply the vegetation standards.

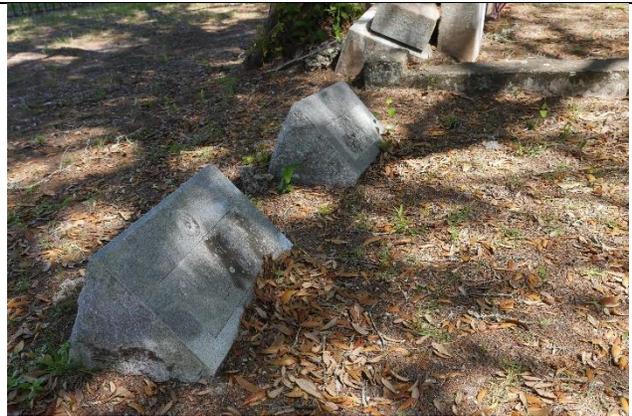
Map Number: 269

This grave is marked by a granite slant headstone with a polished face and rough-dressed sides. It has a cross on the face, but is otherwise largely identical to the adjacent headstone of G. A. Campbell (#270). The stone has settled and is tilted, and there is some lichen growth and biotic staining.

The stone could be leveled, but is a low priority. Apply the vegetation standards as necessary.

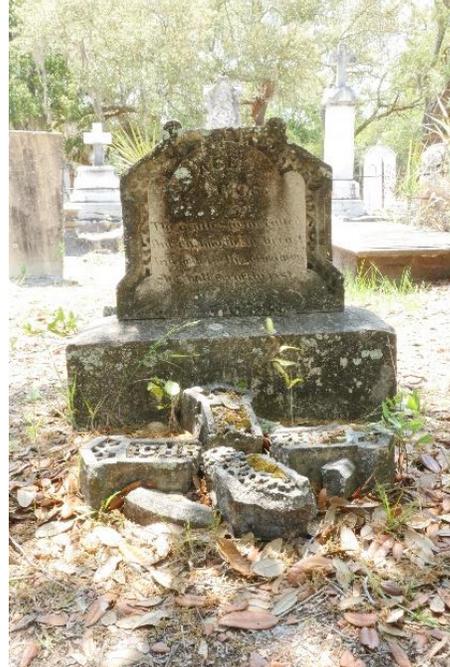
Map Number: 468

This grave is marked by a heavily eroded marble tablet with a two-piece base. The monument rests on a brick and mortar foundation. The monument appears cemented into the top part of base. These top two pieces may have shifted slightly on the base stone. Several foundation bricks are loose and displaced, with 1 brick and a fragment missing. There is heavy lichen growth and biotic staining, and the inscription is faded and indistinct.

Consult a qualified expert to stabilize the foundation and ensure the tablet and upper base stone are secure on their pedestal (lower base stone). Apply the vegetation standards as necessary.

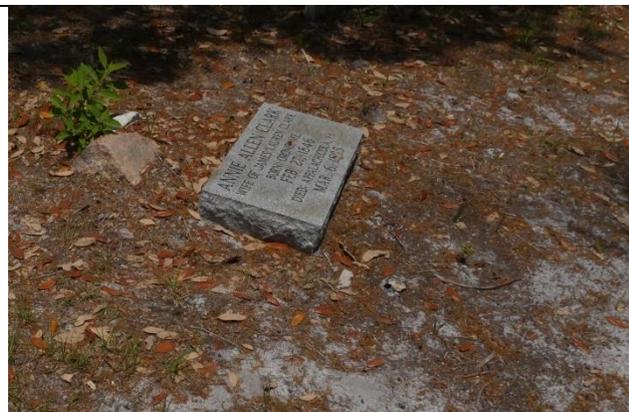
Map Number: 316

This grave is marked by a large, relatively thin, marble tablet with a rounded top. There are a few chips on the edges but no cracks or weak areas are apparent. It leans to the front (east) and to the side (south), but does not appear to be a hazard at present. The base of the tablet is chipped at the corners from mechanical weed trimming. The stone has heavy lichen growth and biotic staining, especially at the rear, but the inscription appears to have been cleaned.

There is a marble round-topped footstone marked "C. C." A fragment is missing at the top left corner. It leans to the south.

Consult an experienced specialist to straighten the monuments. This is not a high priority at present. Apply the vegetation standards as necessary.

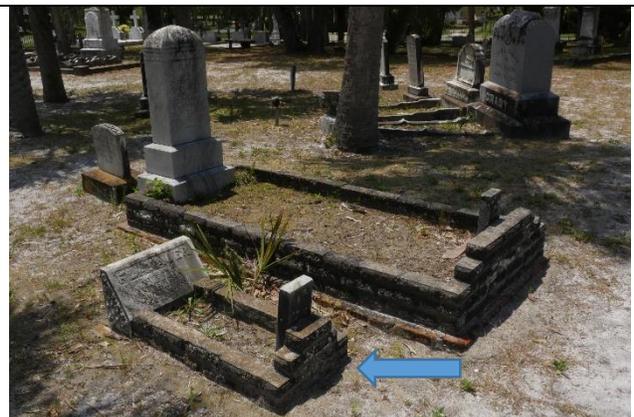
Map Number: 100

This is an infant's grave marked by a slant marble headstone which is polished on the face and rear but rough-dressed on the sides. It has some staining from biotic growth. There is a grave cradle made of cast concrete blocks that is a miniature version of the one used for

the adjacent grave of Freda Flatauer (#99). The foot of the grave cradle consists of a stepped wall with a flat-topped marble footstone standing inside the foot of the cradle. All appears square and level. There is minor lichen growth and staining on the footstone
