Historic Preservation Plan for the Chestnut Street Cemetery Apalachicola, Florida

for the Apalachicola Area Historical Society, Inc.
and City of Apalachicola, Florida

Final Version, June 2016

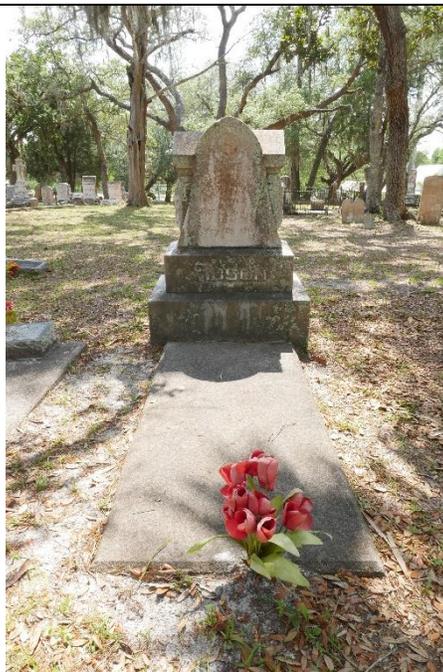
Map Number: 336

This grave is marked by a very large marble Woodmen of the World headstone resting on a two-piece marble base, all over a brick and mortar foundation. The foundation and monument are tilted to the front (east). No elements are displaced or unattached. The concrete ledger is beveled in the same manner as the adjacent grave for Bridget Lovett (#335), but this monument is located behind the head, not on the ledger. The marble has moderate lichen growth and discoloration, but the lichens have apparently been cleaned on the front and rear faces.

Monitor this monument. If the leaning worsens, or if any stones begin to shift, consult a qualified expert to level the monument. Apply the vegetation standards as necessary.

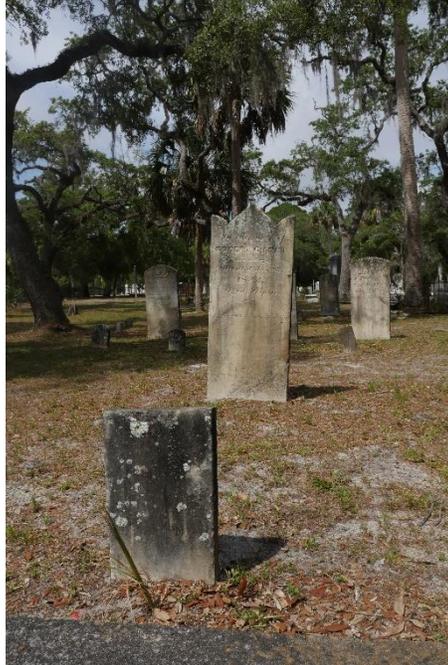
Map Number: 479

This grave is marked by a small marble headstone with a flat top. It is tilted and has a large fragment missing from the side, possibly from spalling. A horizontal crack extends from this damaged area to the center of the headstone at the front, and all the way through the stone at the rear. The rear also includes a large horizontal crack extending from the upper edge to the center. The stone is stained by biotic growth and there is heavy lichen growth on the rear and sides. The inscription appears to have been cleaned in the past.

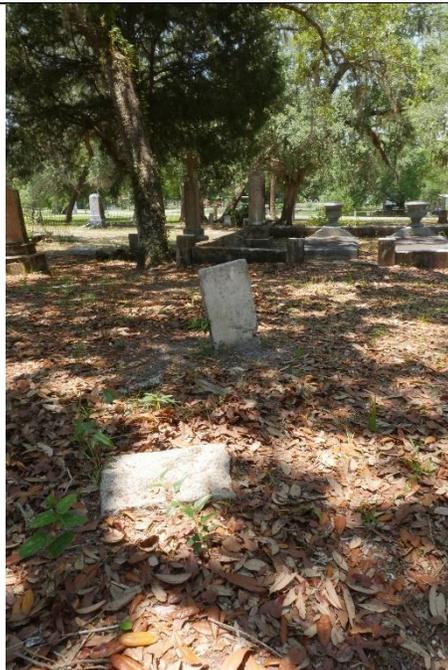
There is a rough granite footstone only 3 to 4 feet east of the headstone. The small size of this grave suggests a child's burial.

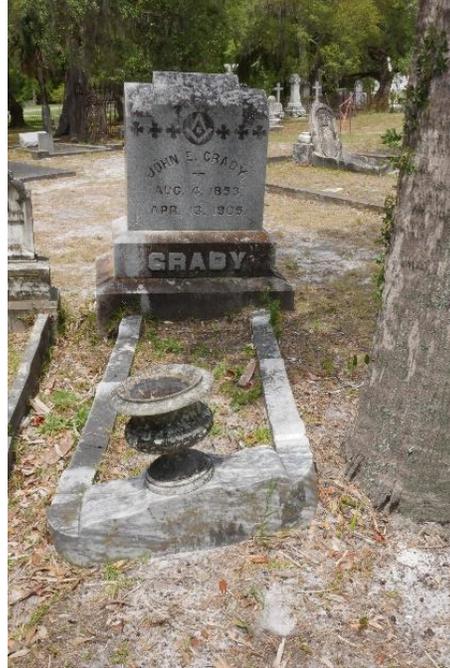
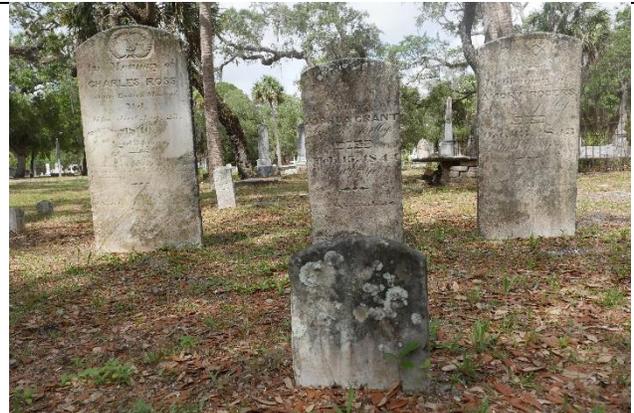
Map Number: 218

This grave is marked by a large marble tablet with a rounded top. There is a crack and a fragment missing at the top north edge. It is plumb and level and solid in the ground. There is lichen growth and discoloration, but the front has been cleaned from the inscription to the bottom. There is a thin marble footstone marked "J. G." It has cracks at the top and loss at the rear edge of the south side. It has heavy lichen growth and black discoloration on all sides.

Apply the vegetation standards as necessary.

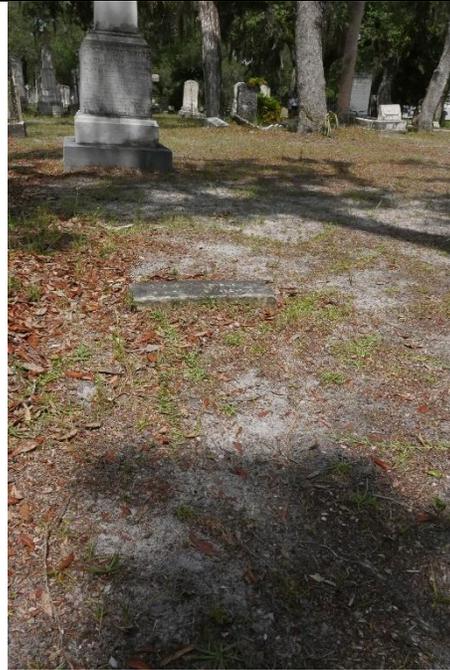
Map Number: 508

This grave is marked by a large marble tablet with a rounded top and a marble footstone. The tablet is stable in the ground. The surface of the tablet is rough and somewhat eroded except at the base. The lettering remains sharply defined. There is a large bedding plane crack at the top of the stone, and delamination and spalling on the rear side. The edges of the stone have numerous chips. There is lichen growth and biotic staining, although the inscription has been cleaned. At the bottom of the grave is a marble footstone with a rounded top marked "J.W.G." It has biotic staining and lichen growth and is stable and level.

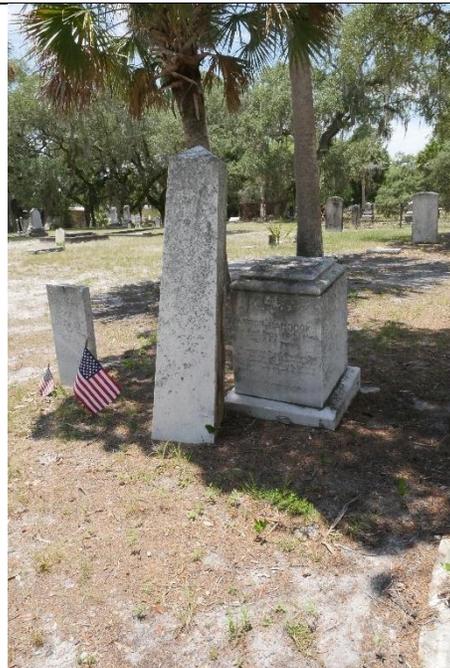
This monument should be monitored. The grave is marked by a marble obelisk and a 2-piece base resting on a marble pedestal. The shaft of the obelisk is detached and standing loose on the ground south and east of the base. It is leaning to the northwest. There are no cracks on the shaft, and there is little evidence of mechanical weed trimming damage at the base of the shaft. This appears to indicate that the obelisk was recently removed from its base and placed on the ground. There is some lichen growth and discoloration of the shaft, although the inscription appears cleaned.

The base is strongly tilted to the east and the upper portion is rotated slightly on the lower base. The top of the base is chipped at the southeast corner. The top, where the obelisk would be attached, has a rough surface, likely to receive adhesive. There is no evidence of a pin or mortise.

The obelisk could be pulled over and should be monitored. If its tilt increases it should be placed on supports, off the ground, with letters facing downward. Seek the guidance of a qualified expert to improve the foundation, reset the base and reattach the shaft of the obelisk. Apply the vegetation standards.

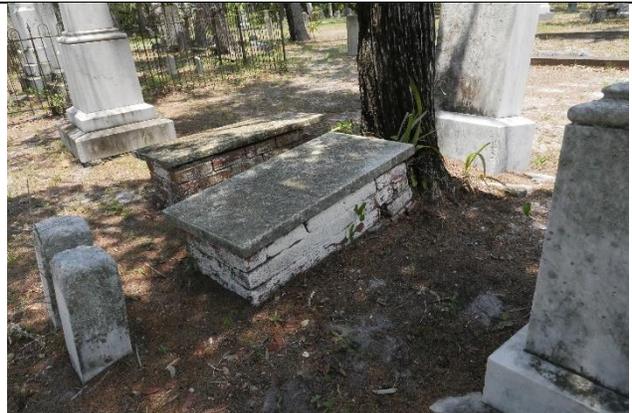
Map Number: 428

This grave is marked by a child-sized marble ledger resting on a brick and mortar base. The brick may have been coated with a lime wash, which is now almost complete eroded. The ledger is broken and cracked at the top northeast corner. The ledger may also be rotated 180 degrees as the inscription is read in the opposite direction as the other nearby Hancock family memorials. The vault is tilted to the north and the southeast corner is uplifted due to the tree growth. The stone is heavily discolored and the inscription is badly eroded.

Consult with a qualified specialist regarding repair of the brick foundation and placing the ledger properly on its base. Be careful of the cracks in the ledger. Apply the vegetation standards.

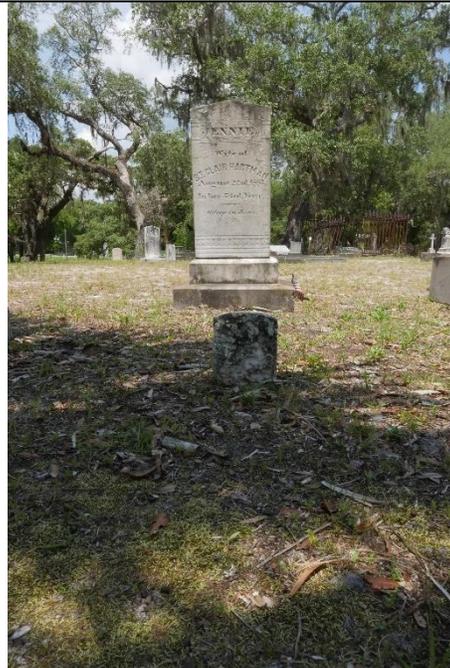
Map Number: 91

This grave is marked by a marble tablet with a pointed top standing on a one-piece marble base over a marble pedestal. The pedestal is leaning forward and to the side due to settling. It remains solid and stable. The monument is heavily stained by biotic growth at the sides and rear and has moderate lichen growth. The face of the monument and inscription have been cleaned. At the base of the grave is a flat-topped CSA military marker with a very slight tilt. It has moderate lichen growth and biotic staining, and there is chipping at the sides from mechanical weed trimming.

The monument could be leveled and straightened, but this is a low priority. Apply the vegetation standards as necessary.

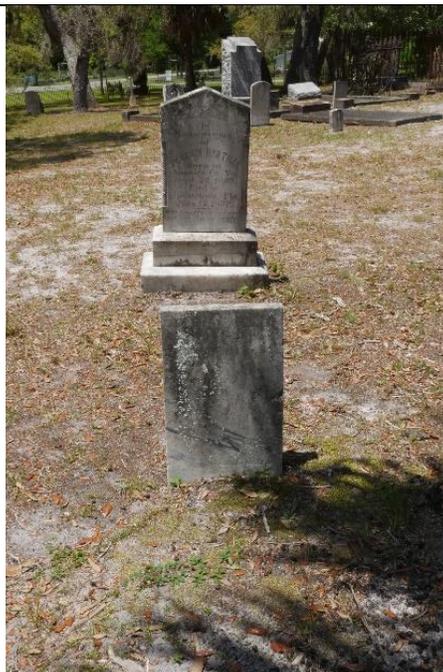
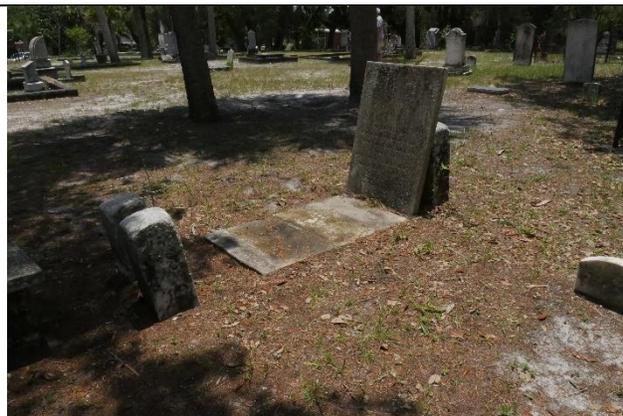
Map Number: 571

This grave is marked by a what appears to be the only table grave monument in the cemetery. It consists of 4 marble piers, 2 at each end and identically spaced, as well as a broken marble ledger with flat sides. One portion of the ledger is buried flat in the ground and is cracked at the center. The upper portion of the ledger carries the inscription and has a large gouge on the southwest side toward the top. It is resting against the piers

on the west side of the grave. Its base is only slightly buried in the ground and the ledger is movable. But it appears stable against the deeply buried piers. The stone has heavy lichen growth and biotic staining, but the inscription has been cleaned. The piers have polished sides and highly eroded tops. The piers at both the head and foot tilt to the east. There is chipping at all corners from mechanical weed trimming.

This monument should be monitored and also offers opportunities for interpretation. The monument does not appear to be repairable, but the leaning ledger should be monitored. Do nothing until consulting with a qualified expert. Owing to the unique nature of the monument, it may be a candidate for interpretation.

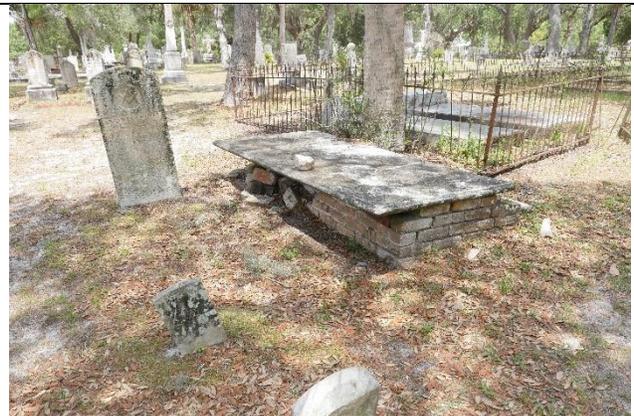
This grave is marked by large, thin marble ledger with beveled sides resting on a brick and mortar vault. The ledger is cracked at the bottom, extending 1 foot toward the center, and is displaced about 6" southward by the growth of an adjacent sabal palm and shrub. The surface is heavily stained and eroded at the inscription on the north side. The vault or foundation is badly deteriorated on all sides. Numerous mortar joints are cracked and many bricks have fallen to the ground, creating a large opening on one side of the vault. This has left the ledger poorly supported except on the east side and at the northwest corner. The ledger is very fragile.

This grave is actively deteriorating and a priority for repair. Consult a qualified expert to carefully remove the ledger and repair the existing bricks to establish a solid foundation. Remove the shrub and consult an arborist about encroachment of the sabal palm roots. Rebuild and repoint the existing brickwork to create a solid foundation for the ledger.

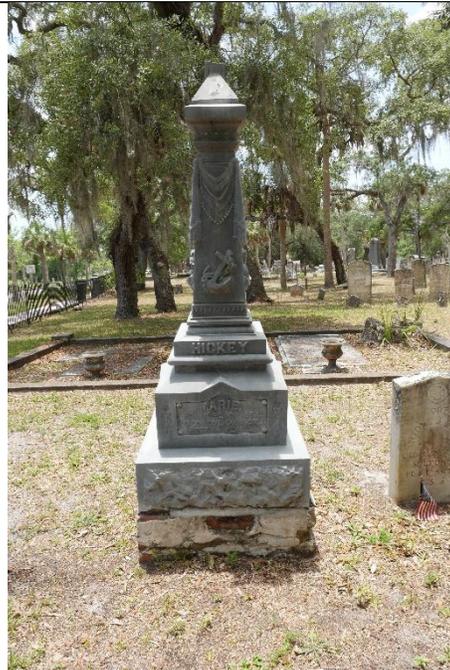
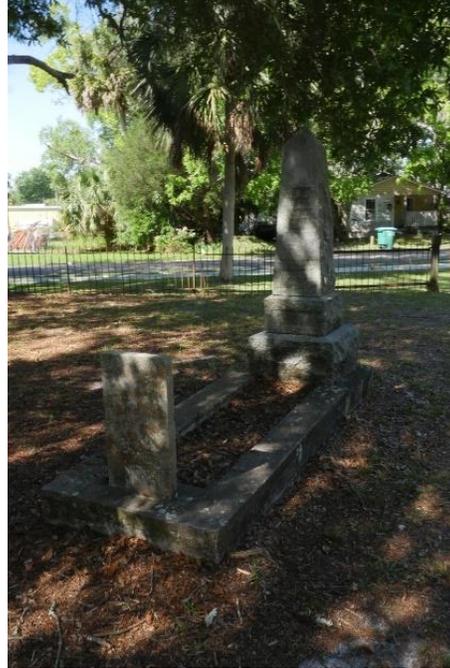
Map Number: 7

This grave is marked by a granite obelisk standing atop a two-piece granite base. The monument rests on a stuccoed brick and mortar foundation which also serves as the rear of the grave border. The sides and rear of the obelisk are rough dressed; only the face of the obelisk shaft with the inscription is polished. There is also a rectangular field inset at the front of the base, perhaps for a plaque. The monument is stained by biotic growth and the inscription is eroding. There are lichens growing on the sides and rear, but the inscription has been cleaned. The grave border consists of a brick and mortar base which has been stuccoed. What appear to be concrete pavers have been attached to the top of the sides and foot. Some of the pavers are cracked near the foot.

Apply the vegetation standards as necessary.

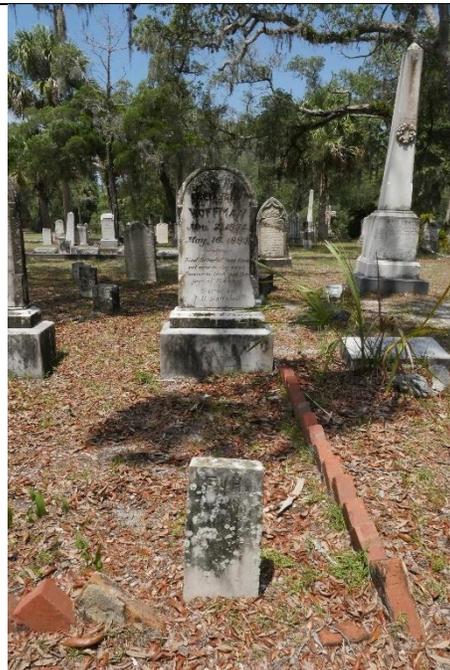
Hoffman, Frederick

The grave includes a marble footstone with a flat top located inside the brick border. It is marked "F. H." with the letters facing outward. It has not

been cleaned and has heavy lichen growth and staining.

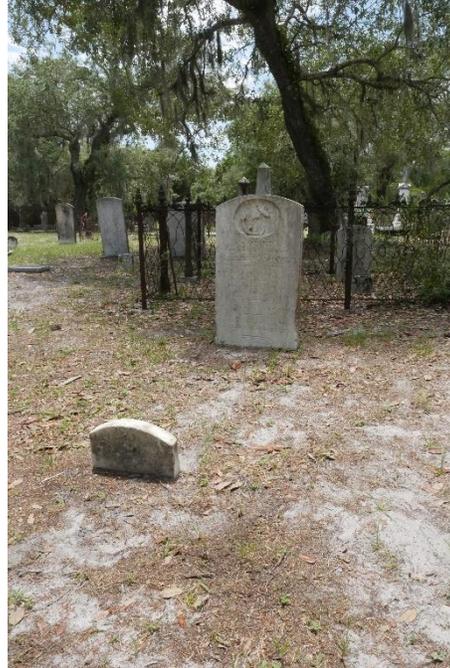
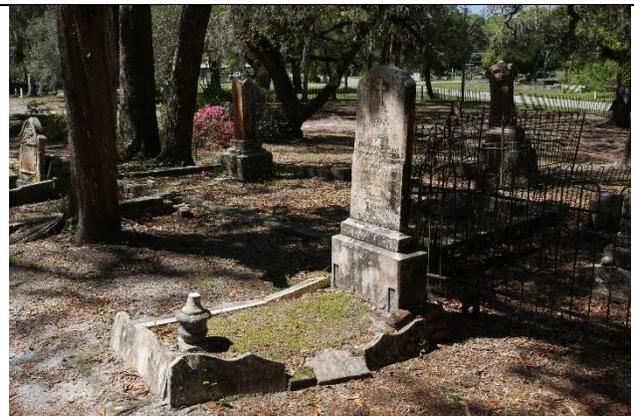
Map Number: 276

This grave is marked by a marble tablet with a rounded top on a marble base and pedestal. It stands on a brick and mortar foundation. The top of the tablet is carved with a cross and the stone has lichen growth and biotic staining. A maker's signature is at the upper corner of the pedestal: "R. E. Todd & Co. Pensacola." There is a marble grave cradle with a scalloped top.

The cradle is cracked at the sides and unattached at the head and foot. The cradle sides are now leaning or have fallen over. The foot of the cradle has a hole for a pin. This was originally used to secure a marble urn, which now stands inside the foot of the grave.

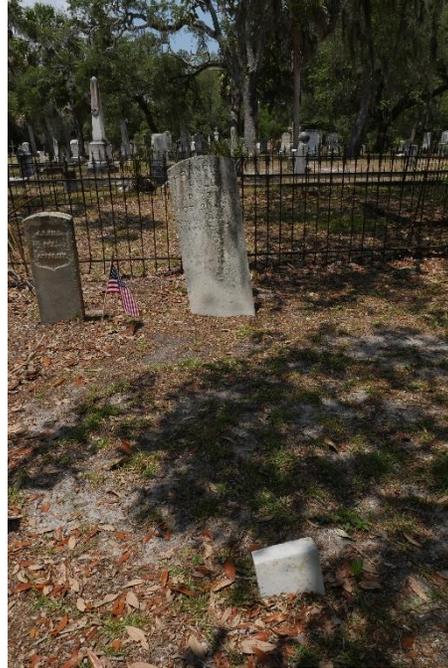
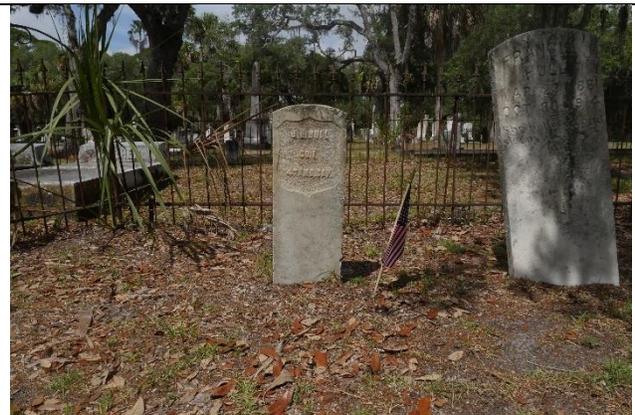
Map Number: 224

This grave is marked by a marble Union Army military marker (Co. I. 4th Mo. Cav.") with a shield motif identical to that of R. R. Hull (#226). It is inset into a concrete foundation which is mostly buried except at the northwest corner. The monument has moderate lichen growth and discoloration, mostly concentrated at the rear. It leans slightly forward (east) and toward the north, but it is solid on its base.

There are chips at the edges near the ground, likely from lawn maintenance equipment.

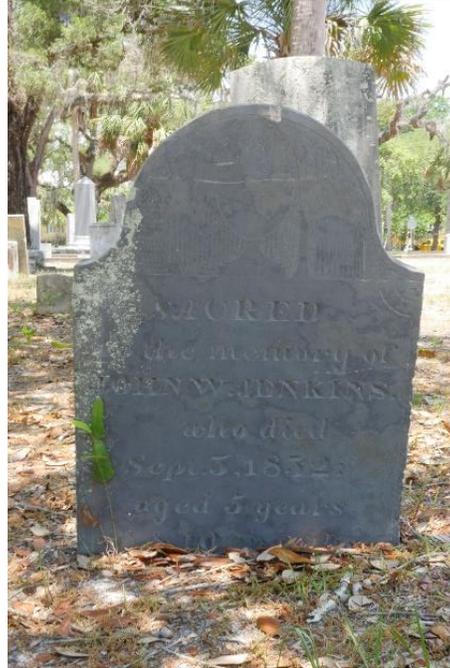
Map Number: 2

This grave is marked by a small marble tablet with a rounded top. It is solid and level in the ground. There is heavy lichen growth and reddish staining, as well as numerous chips at the lower edges of the headstone from mechanical weed trimming. The stone appears to have broken off at the base and been reburied at this level. A recent wood cross has been placed behind the headstone.

Probe to see if the base of the headstone remains buried adjacent to the portion visible today. If so, consult a qualified expert to see if the headstone can be repaired and reset. Apply the vegetation standards as necessary.

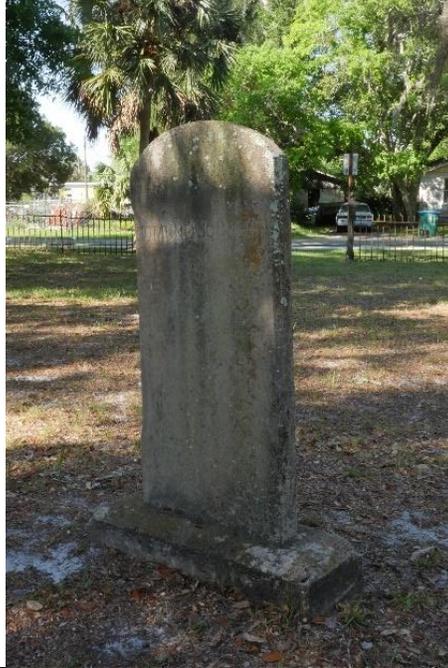
Map Number: 106

This grave is marked by a round-topped marble tablet which is ribbed at the sides and top. It is tilted slightly to the south and has some chipped edges and a large spall at the south side on the rear. There is some lichen growth and staining but the inscription appears cleaned. The grave is edged by a wooden grave cradle that is scalloped on all sides. The corners of the grave cradle are mitered and connected with galvanized nails.

The lower fragment of a marble footstone is located inside the foot of the cradle and set off to the side. **It appears that the upper portion of this footstone, marked "S.S.J.," was relocated within the cemetery and placed at the foot of Jesse Hurd (#220).**

Measure to compare the base of the footstone at this grave with footstone marked "S.S.J." at the foot of Jesse Hurd (#220). If they match, consult an experienced specialist to repair the footstone and reset it in this grave. Leave the wooden grave cradle as it is. Wooden grave cradles are rare at the cemetery and offer possibilities for interpretation.

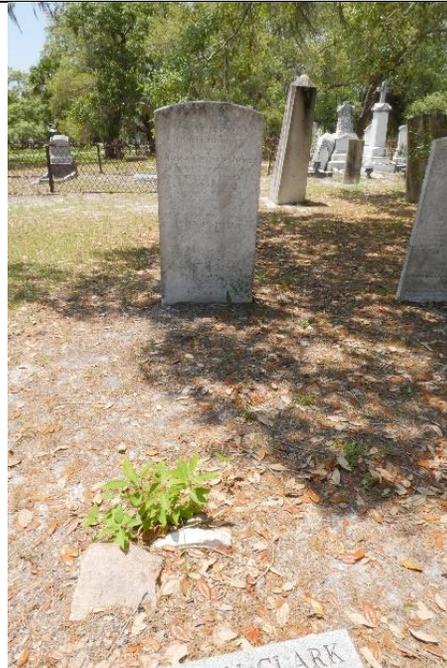
Map Number: 343

This monument is actively deteriorating. The grave is marked by a marble ledger with beveled edges resting on a brick and mortar vault with a stucco finish. The roots of an adjacent cedar tree, likely a memorial tree, have displaced the grave such that the brick masonry on the north side has completely collapsed, leaving the vault open. The ledger remains supported on the south and west sides, but the east side is only partially supported by the trunk of the tree. A flat-topped marble stone has become embedded in the tree roots, but its relationship to this grave is unclear. The ledger is covered by leaf litter and stained by biotic growth. There are many small volunteer plants in the area.

This monument is a priority for repair. Both an arborist and a qualified monument restoration specialist should be consulted. Together they should determine an appropriate approach to stabilizing the grave. It may need to be relocated to avoid future encroachment of the cedar tree. Apply the vegetation standards to remove volunteer growth, especially plants that are growing within or on the monument.

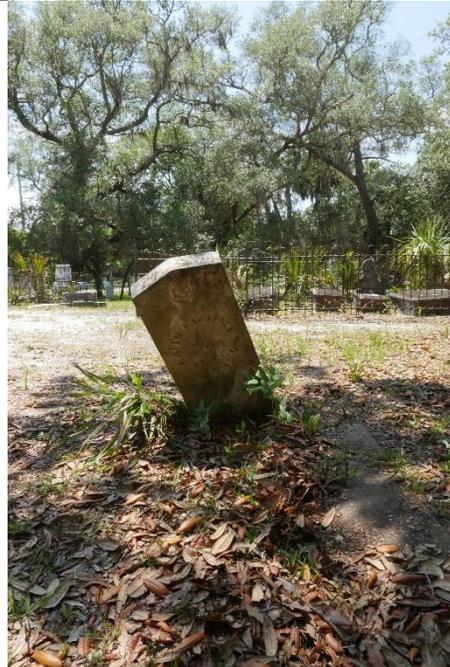
Map Number: 61

This grave is marked by a marble tablet with a rounded top. The lettering on the tablet is worn and the stone is eroding. There is biotic staining and lichen growth on all sides, but the inscription has been cleaned. The headstone rests on a brick and mortar foundation which was originally stuccoed. The mortar is failing and several of the top bricks are slightly displaced. There is an irregular granite block at the foot of the grave. It is unclear whether this is the original footstone.

Apply the vegetation standards as necessary.

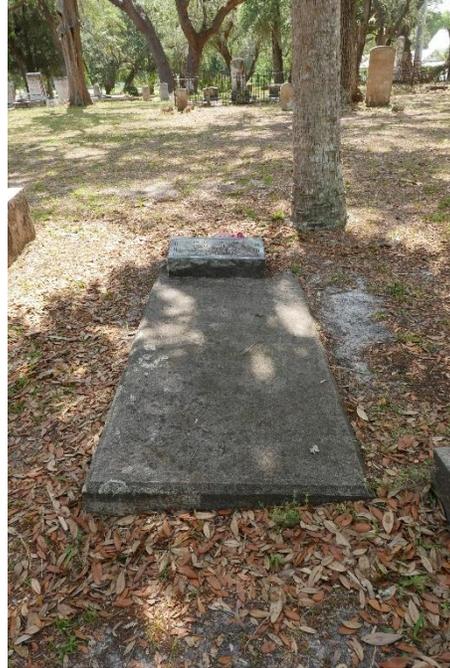
Map Number: 339

This grave requires immediate attention. The grave is marked by a marble tablet that has a crowned top with shoulders. Two previous breaks, more or less horizontal, have been repaired. It is also broken at the tenon, which remains in the mortise on the base. There is a grave cradle with scalloped sides of marble adjoining the concrete beveled bases at the head and foot. The footstone is inset into its base, probably also with a mortise and tenon joint. The south side of the grave cradle is cracked.

The detached tablet is leaning against the footstone in a precarious arrangement. A slight lateral force on the tablet could snap the

footstone and allow both the footstone and tablet to collapse into the marble grave border. There is a risk to anyone nearby and a risk to the monument.

It is recommended that the area be secured by yellow CAUTION tape until the leaning monument can be stabilized. If it is not possible to correct this condition soon, a temporary solution would be to place supports that run the length of the grave cradle and higher than the marble sides of the grave cradle. The headstone could then be stored safely off the ground and out of the soil and with the lettering facing downward. The headstone should be placed so that the cracks run across, rather than parallel to, the supports. Do nothing else at this grave until this dangerous condition has been addressed.

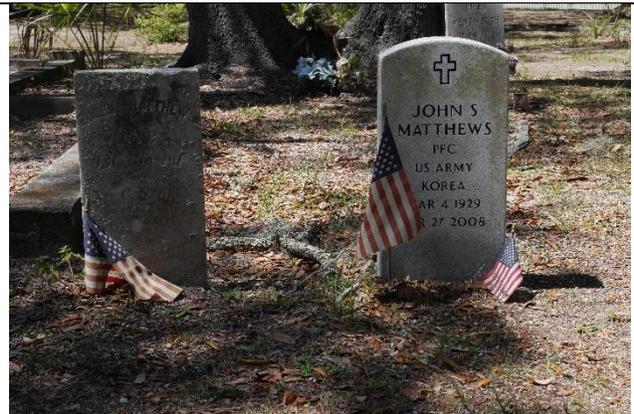
Map Number: 62

This grave is marked by a large upright on a beveled base, both of gray-streaked marble, all on a concrete foundation. The headstone is slightly rotated and offset on the base. The monument is heavily discolored on all sides. There is a rough granite footstone similar to that of Sallie Lawson (#61) nearby.

With advice of a qualified specialist, the stone should be adjusted on its base and the small crack at the bottom of the base on the NW corner should be sealed to prevent continuing separation. Apply the vegetation standards.

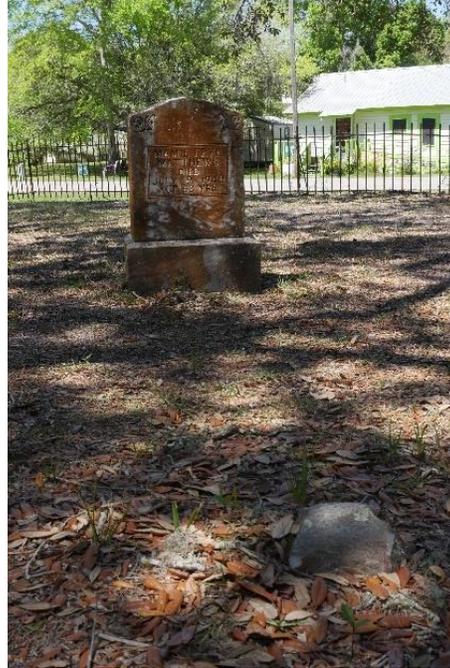
Map Number: 47

This grave is marked by an upright, round-topped marble tablet that is ribbed at the top and edges. The stone is fragile and eroding. There are bedding plane cracks at the top, horizontal cracks, and numerous chips at the edges. There is extensive spalling at the upper rear, and a significant crack at the rear at ground level. The stone has some staining but very little lichen growth. It appears to have been cleaned.

There is a marble flat-topped footstone. It is very fragile with a vertical crack from the top to the ground. There are bedding plane cracks at the top with chips missing, as well as chipping on the edges. The footstone is tilted north and west and inscribed "J. O. Mc.A." with the letters facing the headstone.

Both stones are extremely fragile and should not be treated in any way without the advice of an experienced specialist. If the fence for the adjacent Fuller Lot is repaired, these stones should be protected with a structure to prevent damage.

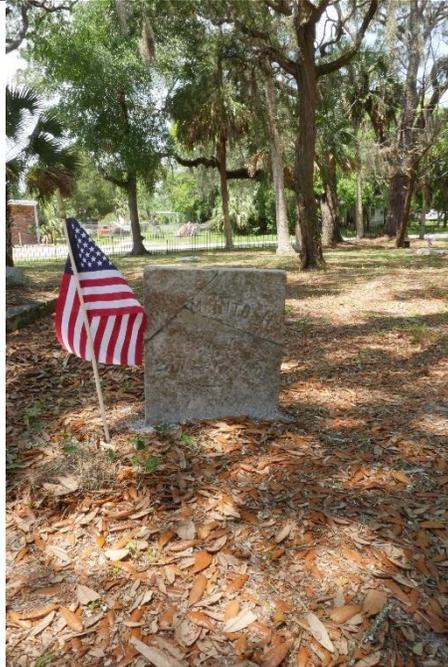
Map Number: 193

This grave is marked by a marble ledger on a brick and mortar base with a stucco surface. The ledger is badly displaced to the south and east on its base. There are no cracks in the ledger but it is chipped at all corners. There is no lichen growth, and it appears to have been recently cleaned. The base is intact with slight stucco loss at the southeast corner.

Reset the ledger and repair the stucco with guidance and supervision of an experienced specialist. Apply the vegetation standards.

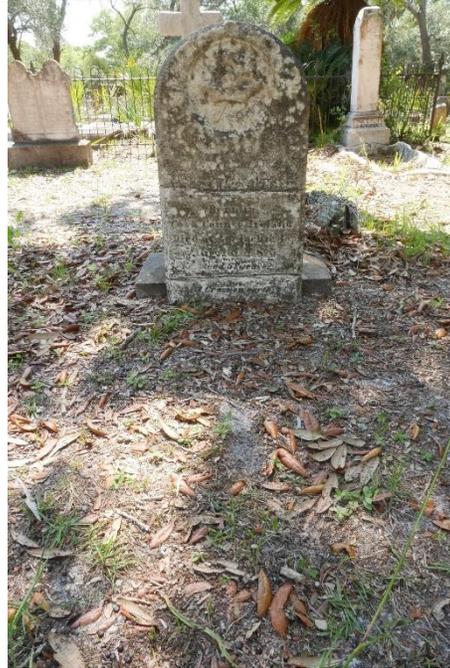
Map Number: 511

This grave is marked by a round-topped marble tablet identical to the adjacent grave of Margaret (#512) with the same crown and cross decoration. This tablet is not broken, but is securely attached to the base by mortar which is also spread across the surface of the beveled base. Lichens and discoloration are moderate, and the inscription appears to have been cleaned.

Apply the vegetation standard.

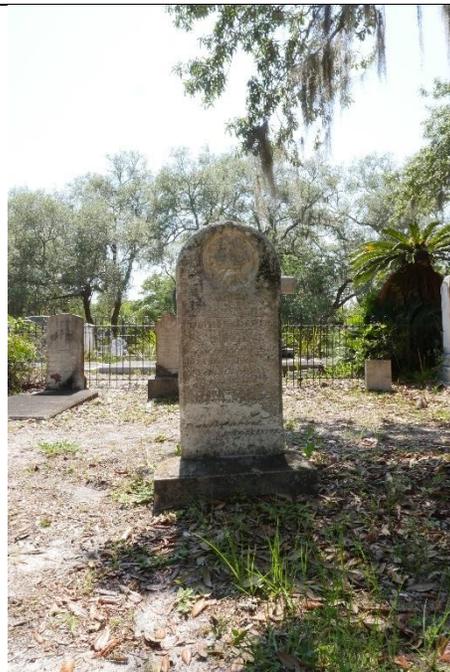
Map Number: 493

This grave is marked by a marble obelisk with cross on top, not attached. There is a hole for a pin to secure the cross, but the pin is broken. The obelisk is displaced on its base, so it is also not securely attached. The brick and mortar foundation is level, but a brick has come loose and is lying at the corner. There is a marble grave cradle. It is intact but the south side is not level.

Consult with a qualified specialist to repair the brick and mortar foundation, straighten and reattach the obelisk to the base, secure the cross on top of the obelisk and level the grave cradle. Apply the vegetation standards. Trim the live oak tree overhead of dead and dying limbs.

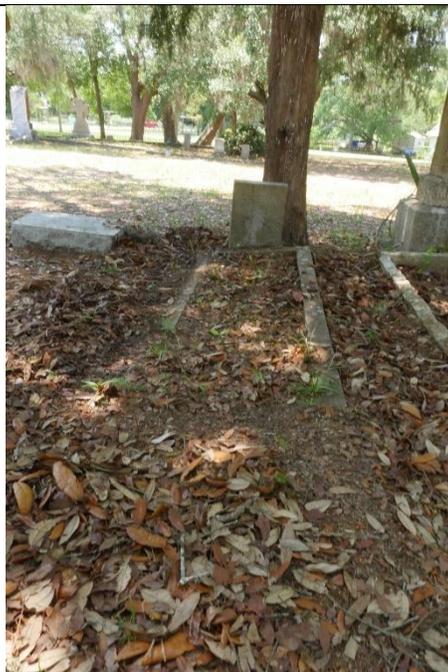
Map Number: 495

This grave is marked by a recent granite beveled headstone resting on a concrete ledger. The ledger is intact where visible, with no cracks or breaks.

Remove soil and leaf litter from ledger and reduce the grade of surrounding soil at the foot and north side to expose the ledger and adjacent concrete cradle of #494.

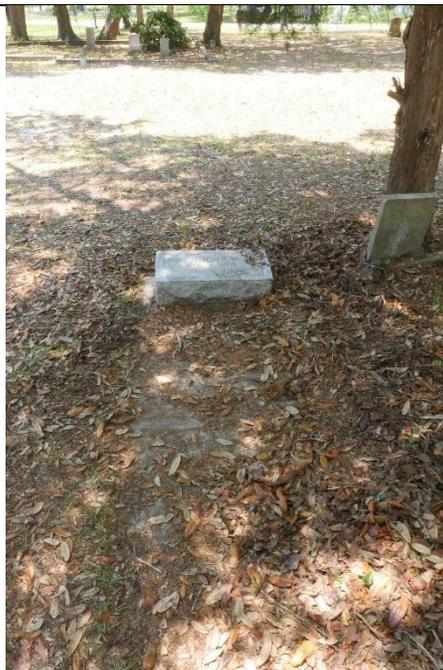
Map Number: 533

This grave is marked by a thin marble tablet with two repaired horizontal breaks. The footstone is marble with another footstone fragment leaning against it. The tablet is stable and plumb. There is heavy dark discoloration on all sides of the tablet and the footstone. Both are fragile

Apply the vegetation standard. If the fence in the adjacent Robinson lot is treated, cover the Megee headstone and footstone with a wood structure to prevent physical or chemical damage.

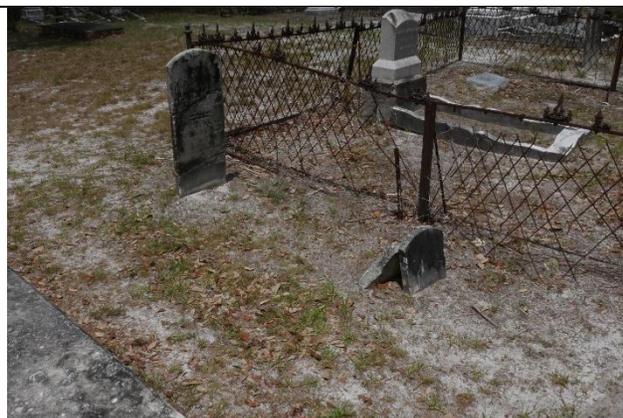
Map Number: 497

This grave is marked by a CSA marble tablet with a flat top. It is in good condition. There is a brick grave border, mostly buried. The monument is straight and plumb.

Remove leaf litter and accumulated soil to uncover the brick grave border. If any bricks are loose, consult with a qualified specialist for repairs. Apply the vegetation standards.

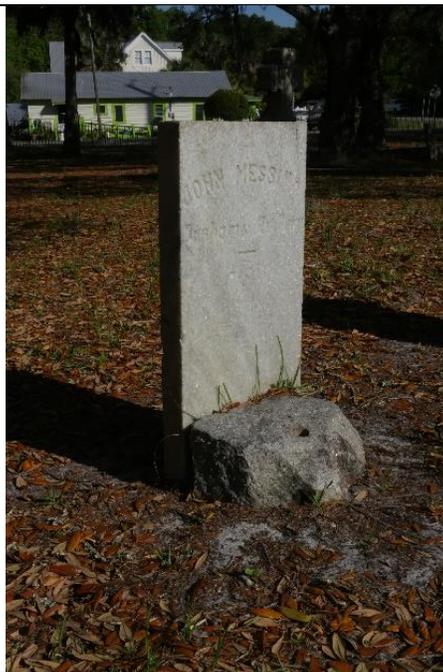
Map Number: 496

This grave is marked by a marble obelisk on a two-part base of marble. There is a grave cradle of marble with head, sides and foot pieces. An element at the top of the obelisk, possibly a cross, has broken off at the mortise and tenon joint. The tenon is still in the mortise, and appears to have been repaired previously. The obelisk and bases are tilted to the south, and the obelisk has shifted slightly. Lichens and discoloration are light on the front but heavy on the shaded side. The cradle side pieces have pivoted outward around their mounting pins. The foot is covered and sunken at the northeast corner. Vegetation encroaching from behind at fence and around cradle.

Check pieces of cross behind the monument of Micharla Messina, third grave south to see if any fit to the top of the obelisk. If this is the missing cross, consult with a qualified specialist regarding a possible repair. Straighten and level cradle side pieces. Monitor leaning and address if it increases. Apply the vegetation standards.

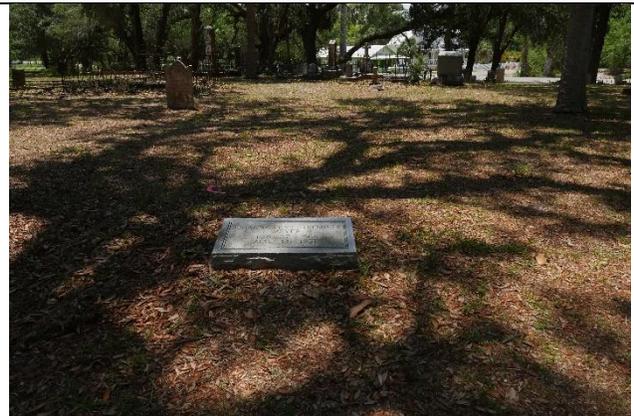
Map Number: 394

This grave is marked by a flat-topped CSA military marker of marble. There are a few chips on the edges. It is solid in the ground. Black staining due to biotic growth is present, mostly on the front face. There are lichens at the south side and the stone leans slightly toward the back (west).

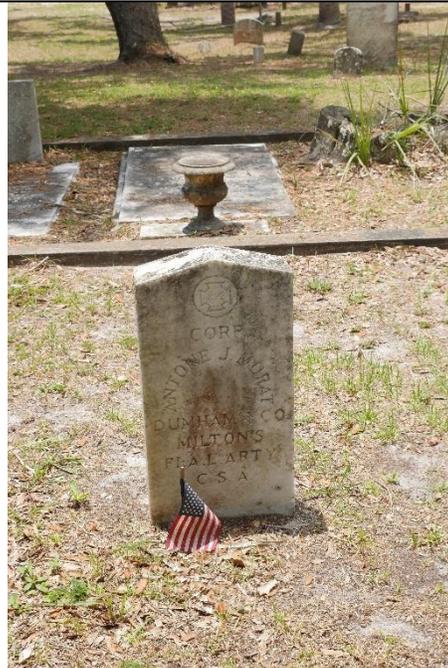
Map Number: 391

This grave is marked by an ornately carved marble upright monument on a marble base over a brick and mortar foundation with stucco. There is a marble grave cradle which is scalloped on all sides. The foot piece of the grave cradle is wider with a platform at the center. The urn base is still attached and the urn bowl is present and upside down over the base. There is another urn segment at the foot but it does not seem to fit the other pieces. The headstone appears to have been cleaned; there are no lichens and discoloration is minimal. The base has some dark staining. The north grave cradle is cracked at the center and broken at the foot. The head and sides of the grave cradle rest on a brick and mortar foundation.

Apply the vegetation standards. The urn could be reattached back to its base with a new pin and adhesive, but the bowl is mostly missing. The grave cradle sides lean outward slightly and could be straightened, but all parts are stable and present no risk.

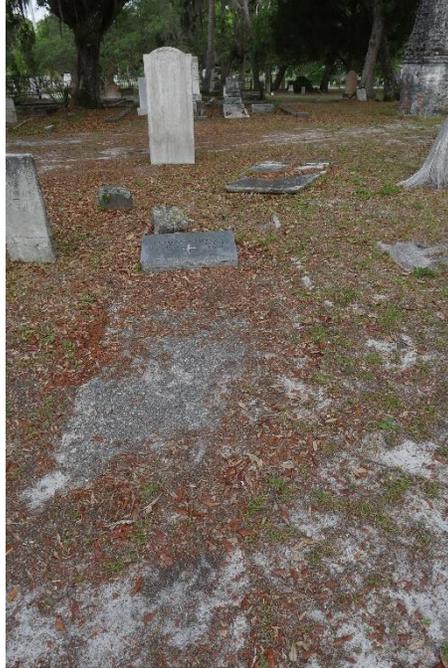
Map Number: 411

This grave is marked by a flat-topped marble CSA military marker, plumb and level, with a previously repaired horizontal break toward the base below the lettering. It is solid in the ground, but slightly tilted forward. There is a bronze military marker at the foot.

Apply the vegetation standards.

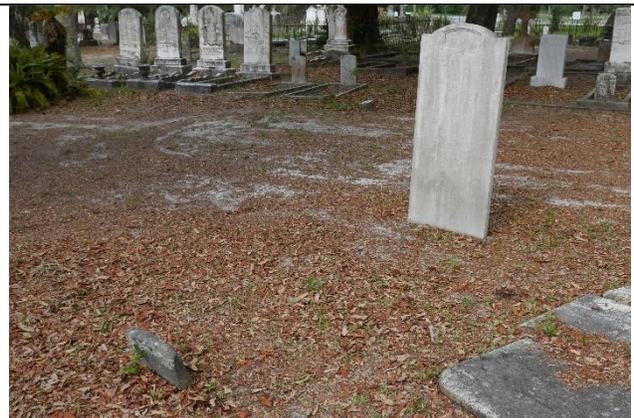
Map Numbers: 320, 321

Two graves are marked by one monument, a marble double round top tablet. It appears to have been recently cleaned at the inscription and on the back. There is a long diagonal striation in the stone at the bottom front; it is not a crack but possibly an area of weakness. There are some chips on the edges and one spall at the top on the south half. The tablet leans to the south side very slightly, but it is quite solid in the ground. There is no need to reset the monument.

There is a very thin marble footstone, also with a double round top. There are small chips at the top and side edges, but it is otherwise in very good condition. The grave border consists of diagonal dry laid brick at the edges and sides, and flat on edge at the foot. Lichens and discoloration are light on the tablet, which has apparently been cleaned, but heavy on the footstone.

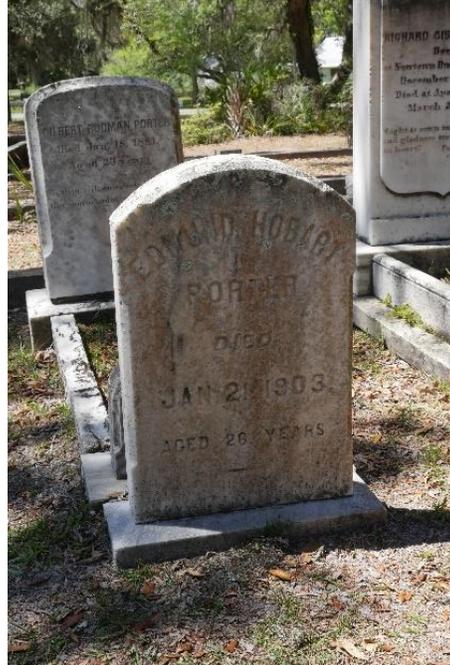
Map Number: 457

This grave is marked by a thick marble tablet on a marble base above a brick and mortar foundation. The base and foundation have settled at the front, which tilted the tablet forward. This was addressed by sliding something to act as a spacer, perhaps a metal rod, under the front edge, levelling the tablet. There is a grave cradle with flat side borders and a wide flat foot border which serves as a base of footstone. This thick low footstone is marked "G.R.P." The marble side grave borders are broken at middle and slightly separated from head and foot bases.

The connection between the headstone and its base should be further examined by a qualified person to be sure that the connection is secure and stable.

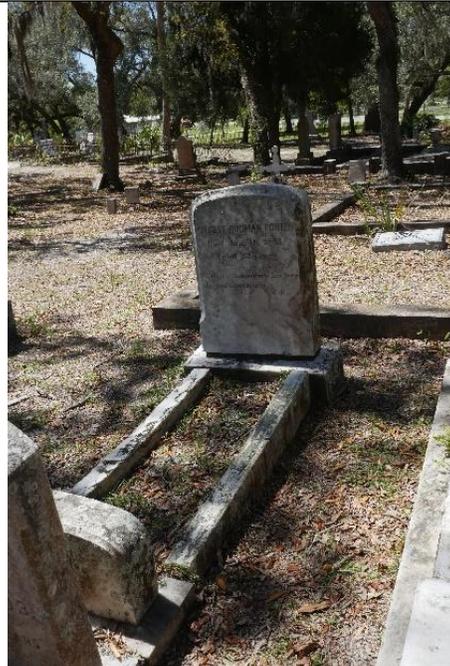
Map Number: 456

This grave is marked by a concrete border with multiple cracks and breaks especially at the northeast corner. A relatively recent thick granite thick upright with engraved name "Ida" on slant top was placed at the head on a granite base. The arrangement is identical to that of Thomas F. Porter (#457) in the adjacent grave.

Apply the vegetation standards.

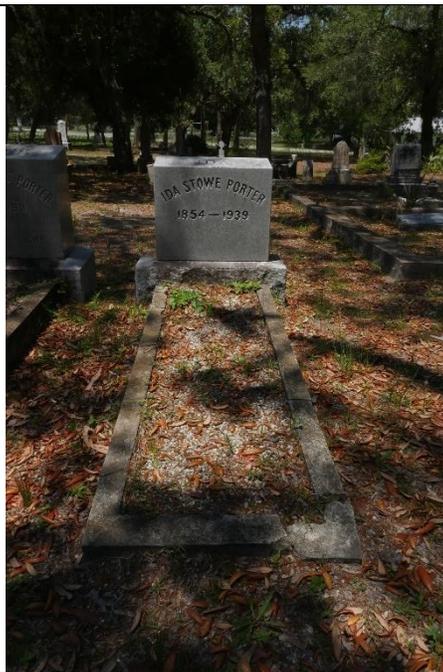
Map Number: 460

This grave is marked by a marble upright on a marble base with flat marble grave side borders. The wide marble foot border is the base for a marble footstone with letters M.T.P. facing away from the headstone. All elements are in good condition. There is a slight tilt but the monument is stable.

Apply the vegetation standards.

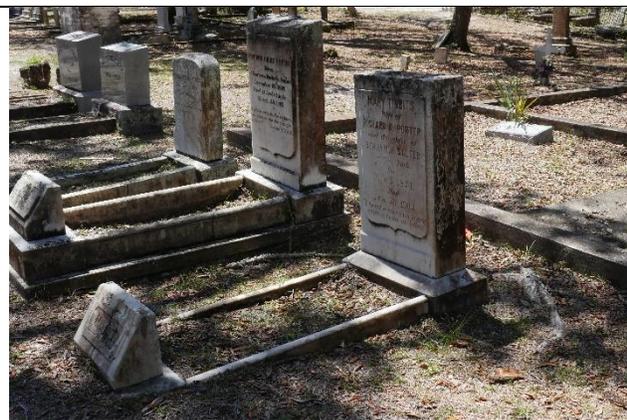
Map Number: 322

This grave is marked by a marble tablet with a pointed and shouldered top. It appears to have been cleaned of lichens at the front, and probably also at the rear. The marble shows a large bedding plan crack on the top and chipping on the edges. There is a diagonal crack on the face but little stone loss so far. Leans very slightly to the north.

There is a flat-topped marble footstone marked "P.P." It has heavy lichen growth and black staining from biotic growth.

The monument is fragile; do not attempt to straighten it. Apply the vegetation standards.

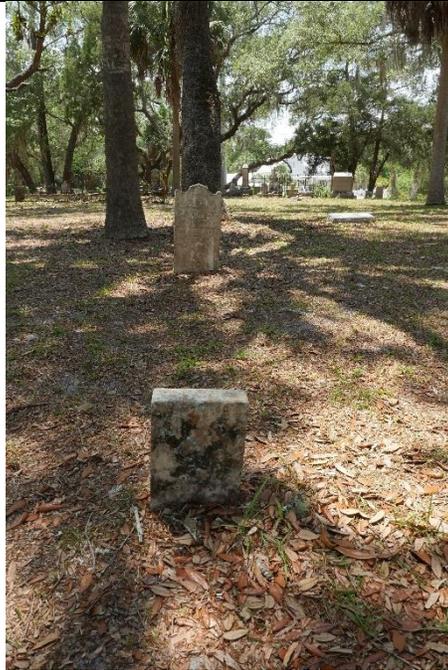
Map Number: 459

This grave is marked by a marble upright on marble base with flat marble grave side borders and a wide foot border. It is essentially identical to the monument for John Gibbs Ruan (#415). The foot border supports a marble footstone marked R.G.P. All the monument elements rest on a single marble slab which is cut out in the grave center. The monument is in good condition, with a slight lean to the north at the head.

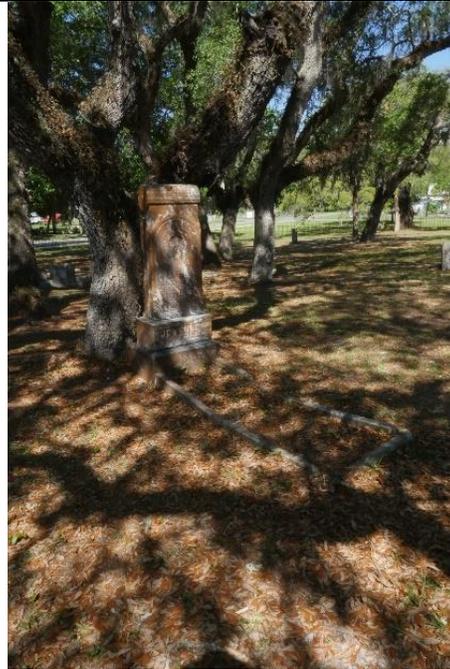
Map Number: 398

This grave is marked by a headstone constructed of brick and mortar and faced with stucco. It has a rounded top and is shouldered. There are no letters on the headstone. There is a flat-topped marble CSA military marker inside at the foot. Several memorial plants at foot on the north side including coontie and possibly Yaupon holly are shading and encroaching upon this grave. The brick border is cracked and displaced at northeast side possible due to plant growth.

Prune the coontie palm and determine whether this is the cause of border displacement. Do not remove any potential memorial plants until the grave has been evaluated by a horticulturalist with historic cemetery experience.

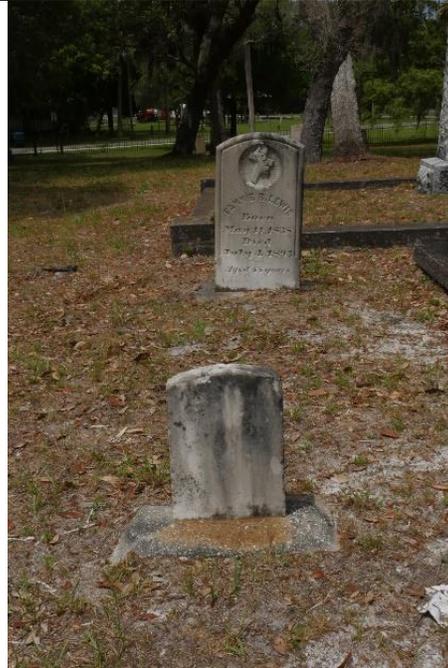
Map Number: 416

This grave is marked by a marble beveled headstone. It is discolored by biotic staining and there is a chip at the southeast top corner and small chips on the edges. There is a footstone with no lettering consisting of a rough rock with two parallel finished sides.

Apply the vegetation standards as necessary.

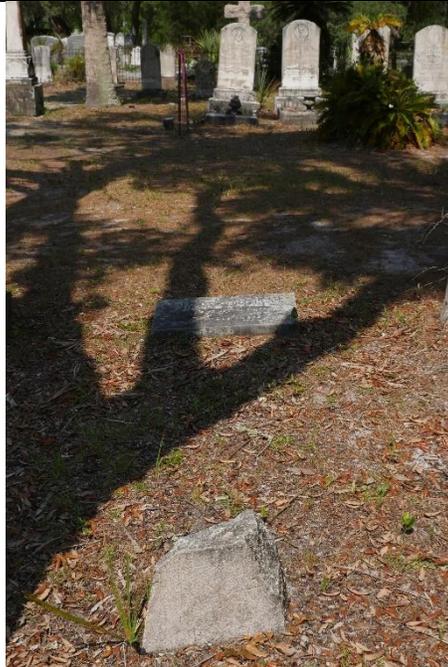
Map Number: 207

This grave is marked by a thick marble tablet with a rounded top. It is very likely this tablet is actually the top of a taller monument which was broken off and reburied at this level. It has a very slight lean to the north but is plumb. The edges of the monument are chipped, and there is staining and heavy lichen growth except at the inscription, which appears cleaned. There is a marble footstone with a rounded top inscribed "J.R." It is tilted to the side and has biotic staining and lichen growth. The edges are chipped, likely from mechanical weed trimming.

Probe to see if the base of the monument is still buried in the ground adjacent to the visible portion of the headstone. If so, consult a qualified expert to see if the tablet can be repaired and reset. Straighten the footstone at

the same time. Apply the vegetation standards as necessary.

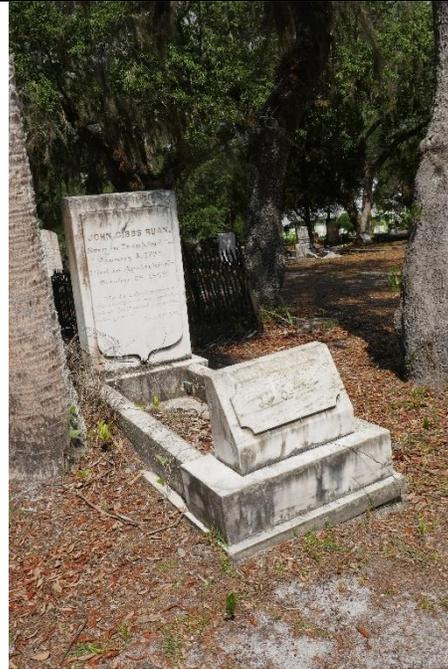
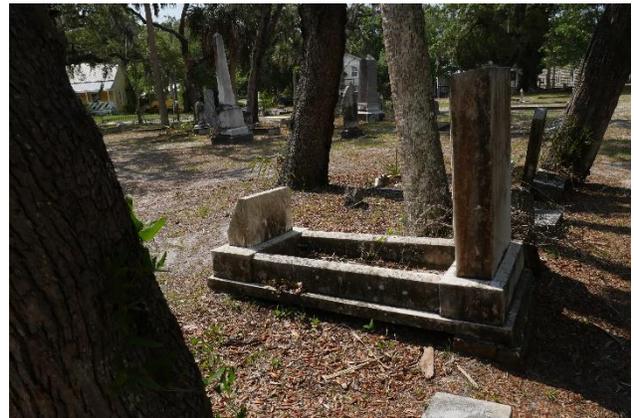
This grave is marked by an impressive and finely crafted marble monument that is essentially identical to the grave of Richard Gibbs Porter (#459). It features a thick marble headstone resting on a marble pedestal, with a thick grave cradle and a large beveled footstone. The base of the monument is a marble slab which is cut out inside the grave border. The head of the monument rests on a brick and mortar foundation, and some brick is also visible at the edge of the foot. The grave is tilted and has sunk to the southeast toward an adjacent sabal palm and the stump of a cedar tree. This sinking has tilted the marble slab to the extent that it is elevated above the grade of the soil on the side away from the tree.

The headstone features a large raised shield and the grave border sides are beveled at the top. **The headstone is not secure on its base and is leaning slightly forward.** The footstone has a raised field marked "J. G. R." All components of the monument are discolored by biotic staining.

This grave should be monitored and is a priority for repair. The headstone has not shifted but it is very large and not secure on its base. Consult an experienced cemetery specialist about stabilizing the monument. It may also be necessary to consult a professional arborist regarding the sabal palm and adjacent stump.

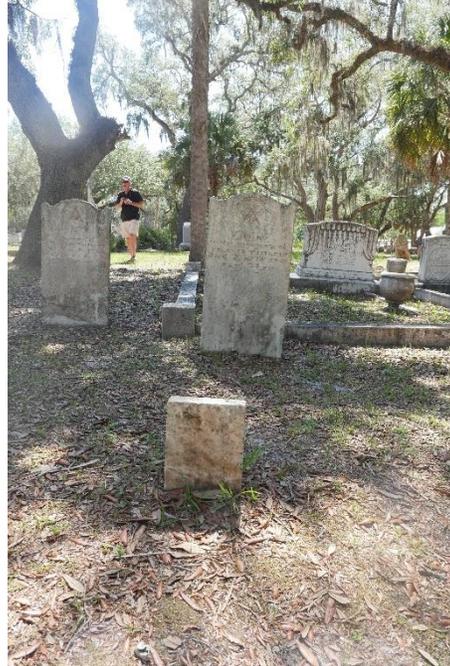
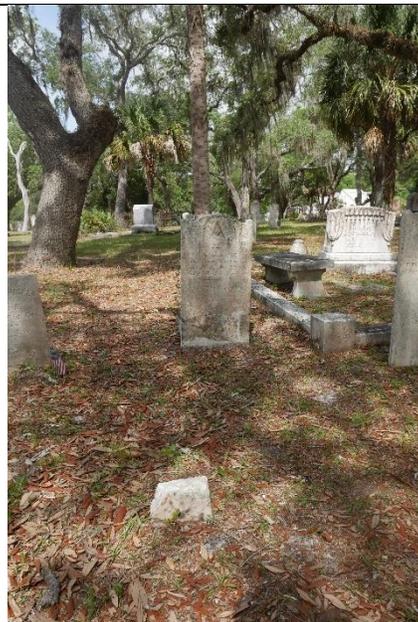
Map Number: 357

This grave is marked by a crowned marble tablet and inscribed with a Masonic symbol. It is essentially identical to the adjacent monument for Travis Thigpin (#356). There are bedding plane cracks at the base in front and at the south side of the rear near the top. The monument appears fragile although is not tilted or leaning and is solid in the ground. There is lichen growth and discoloration, although the inscription has been cleaned. A planter has been placed behind the headstone, consisting of a metal pail.

There is a flat-topped footstone marked "W.T." It has a large chip at the south side of the top. Both the headstone and footstone have been chipped at the edges by mechanical weed trimming.
