Historic Preservation Plan for the Chestnut Street Cemetery Apalachicola, Florida

for the Apalachicola Area Historical Society, Inc.
and City of Apalachicola, Florida

Final Version, June 2016

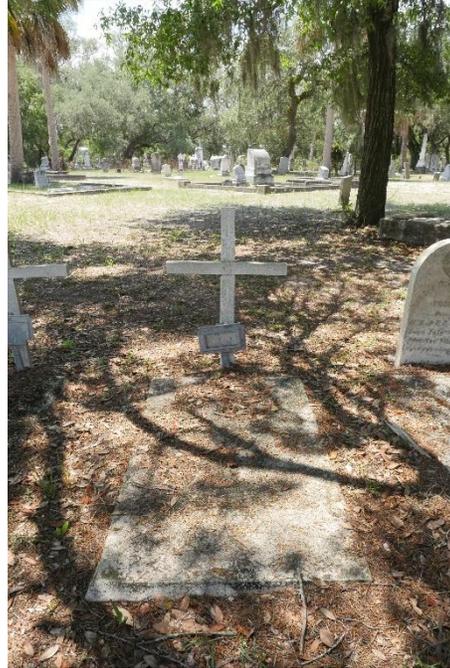
Map Number: 42

This grave is marked by a child-size concrete ledger with beveled edges all around. It is identical to the adjacent unknown burial #41, except this ledger is smaller. There is a recent wood cross and a metal funeral home marker which is missing its label.

Apply the vegetation standards. See recommendations for Unknown Burial (#41) for identifying deceased.

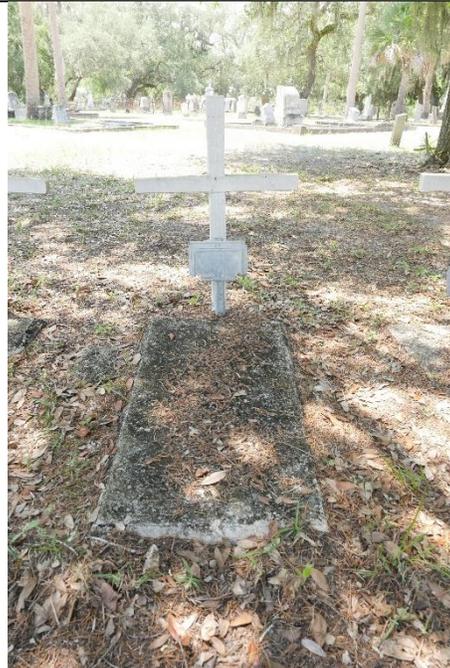
Map Number: 43

This grave is marked by a child-size concrete ledger with beveled edges all around. It is identical to the adjacent unknown burial #42. There is a recent wood cross and a metal funeral home marker which is missing its label.

Apply the vegetation standards. See recommendations for Unknown Burial (#41) for identifying deceased.

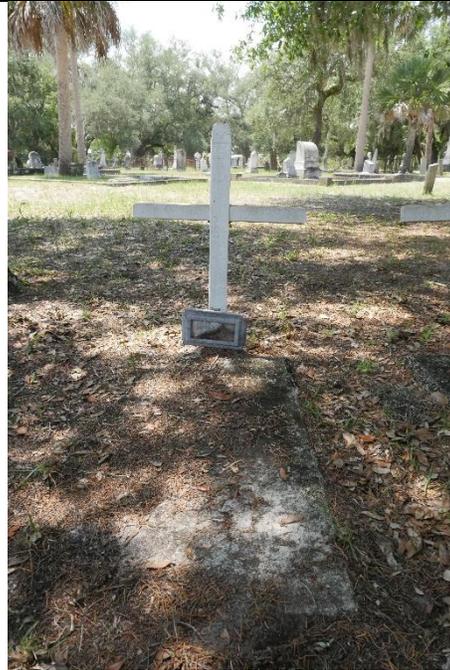
Map Number: 51

This grave, situated behind the Catanetti lot, is marked by a plain concrete ledger with beveled edges and no inscription. It is level and in good condition with no cracks or breaks.

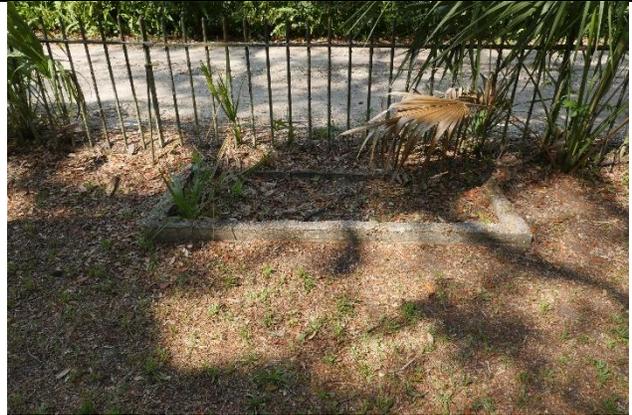
Map Number: 350

This grave is marked by brick and mortar “vernacular” grave markers with a brick and mortar foundation and footstones and grave cradle, all of flat-laid brick. The present example with sides one brick in width has deteriorated the most.

Consult with a qualified specialist regarding reconstruction of the brick and mortar monumentation. Remove vegetation and debris in accordance with the vegetation standards.

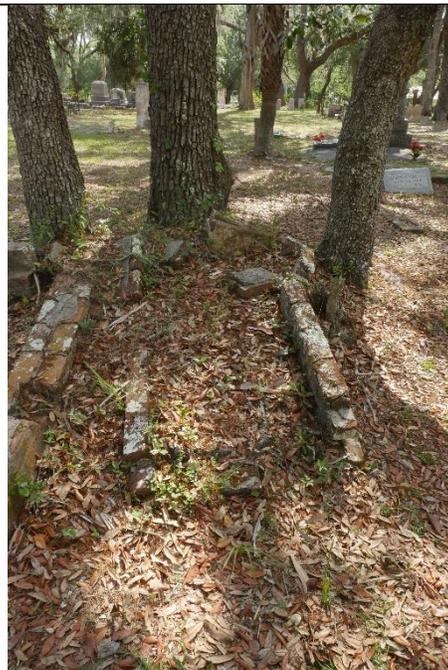
Map Number: 351

This grave is marked by a brick and mortar monument with headstone and footstone and grave border, all of double-width brick and mortar. It is deteriorated and displaced by a live oak tree at the head.

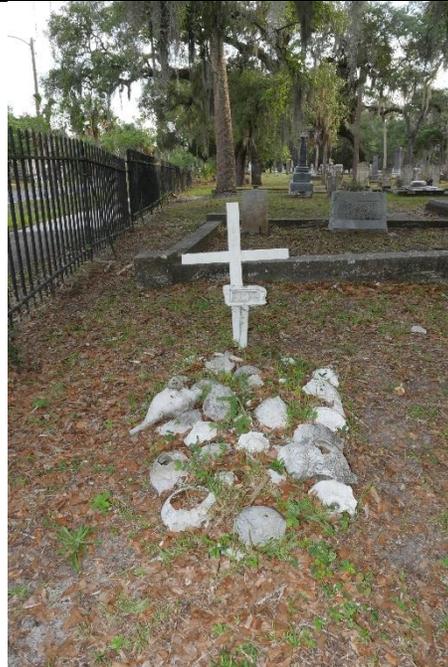
Map Number: 555

This grave is a hazard. The top of what appears to be a barrel vault or simply a rounded ledger is broken through in at least three places and has recently been uncovered at the south side. **It is possible that a person or equipment could fall through into the grave.** The grave is also marked by a recent white wood cross.

It is recommended that the grave be secured by yellow CAUTION tape until the broken vault can be stabilized. Do not attempt any further digging to uncover the vault. This grave should be assessed by a specialist experienced in historic cemetery restoration and repair. Apply the vegetation standards.

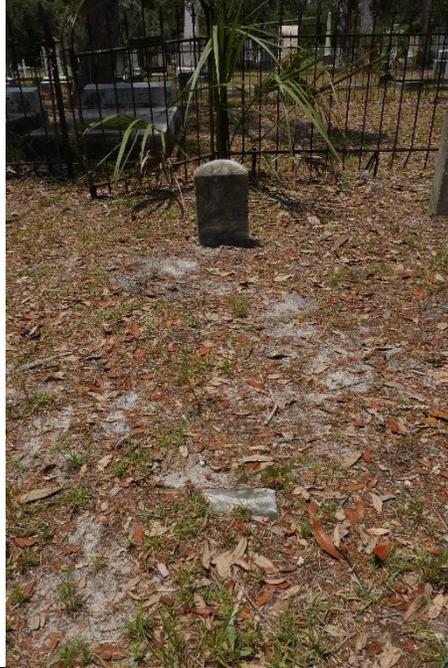
Map Number: 386

This grave is marked by a large marble tablet with a rounded top and shoulders. The edges and the top are eroded but no cracks or weaknesses are visible. There is heavy lichen growth on the back with discoloration, but the front side lettering has been cleaned of lichens. The tablet leans strongly to the rear (west) but it is solid in the ground and does not appear to be at risk.

The monument could be straightened but does not appear to be a risk at present. Apply the vegetation standards.

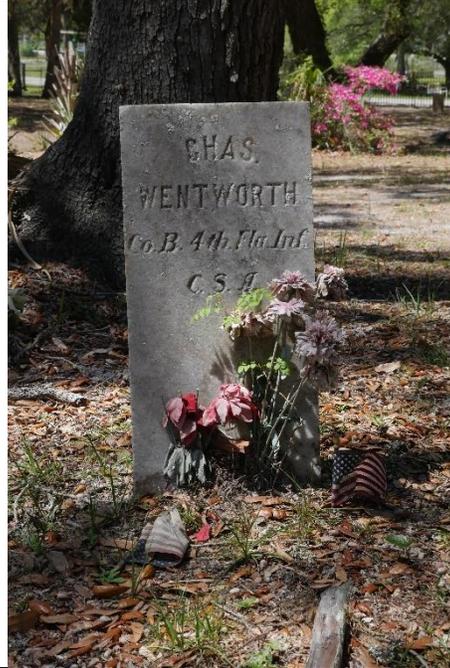
Map Number: 5

This grave is marked by a relatively thin marble tablet with a rounded top. The stone is soft, based on the condition of the inscription and edges, and should be treated with extra caution. The tablet leans to the south side. A piece of asphalt and a broken urn base are next to the tablet at the front and the NE corner. Lichens and discoloration are heaviest on the shaded back and edges, and it appears that the front has been cleaned. mildew and _____, much heavier on shaded back ends and _____ edge.

The tablet should be straightened, but it may well be fragile, at least at the surface, and this work should be done by or under the supervision of an experienced and qualified specialist.

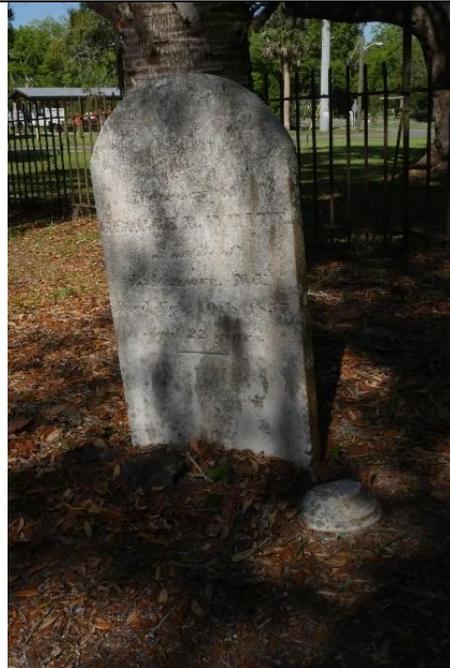
Map Number: 594A, 594B

This grave is marked by a granite beveled headstone with rough dressed sides and a polished border around the inscription. The monument marks two graves. The stone is fairly new and in good condition. It sits level and square in the ground.

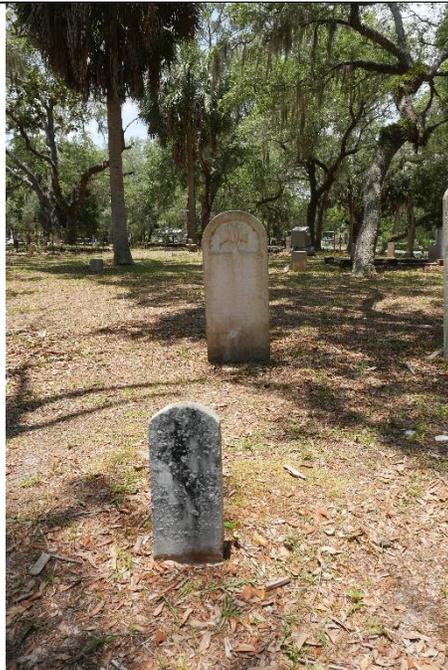
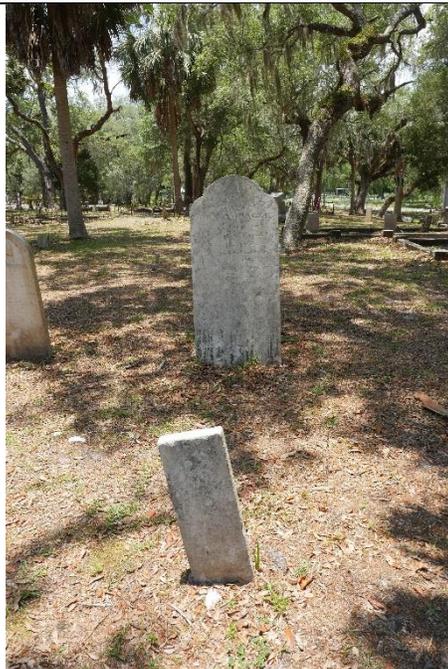
Map Number: 308

This grave is marked by a large and relatively thin marble tablet. It leans backward to the west. There are chipping and scratches on north edge. The stone has been recently cleaned on all sides. The top edge shows a diagonally oriented texture rather like irregular ridges. It is not solid in the ground, but currently does not appear to be at risk of falling.

There is a marble flat-topped footstone marked J. Y. It has heavy lichen growth and is tilted south and west.

Apply the vegetation standards. After experience is gained with other monuments, reset, plumb and square the monument, as well as the footstone.

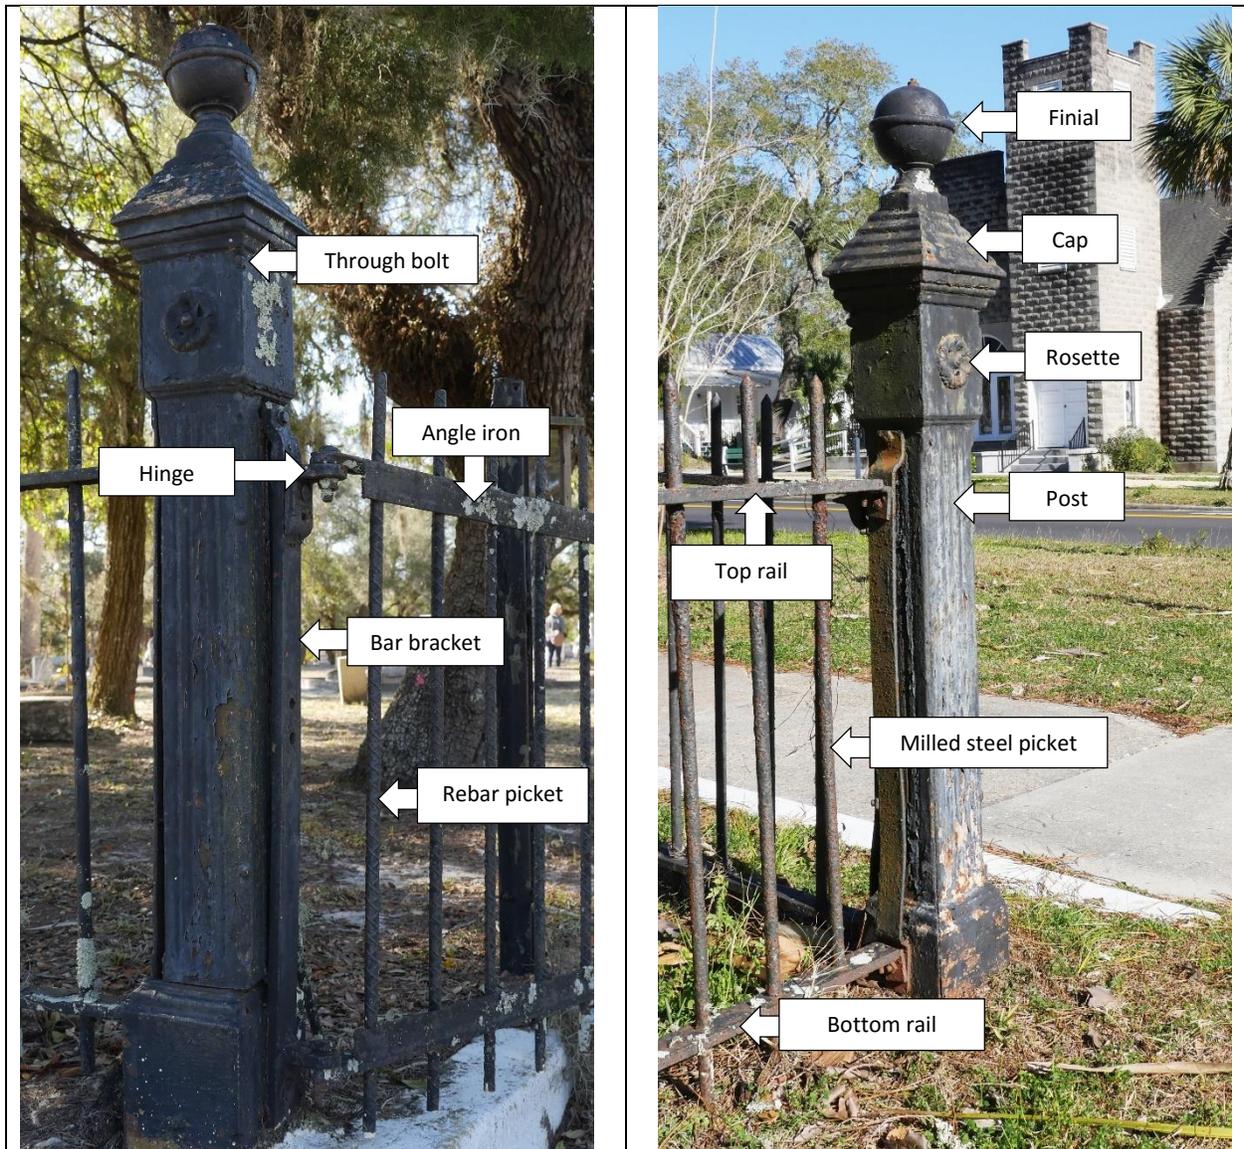
There are three gates in the Cemetery: the Front Gate (Gate 1), the Side Gate (Gate 2), and the Rear Gate (Gate 3). These gates are all made of angle iron with pickets of rebar steel and are very different in appearance from the fence panels. It was unclear during the early part of the project whether the rebar and angle iron represented replacement or repaired gates to replace the originals, or whether they date from the construction of the fence around 1915. After all the work was completed, several facts became apparent. All three gates are constructed in the same way with the same unique materials, and have apparently original hardware such as hinges and bar brackets. In addition, the same rebar and angle iron appears at several other locations in the fence, but only for a short distance between the last regular panel and a post. This pattern suggests that rebar and angle iron was used in the original construction for gates and where purchased panels would not fit.

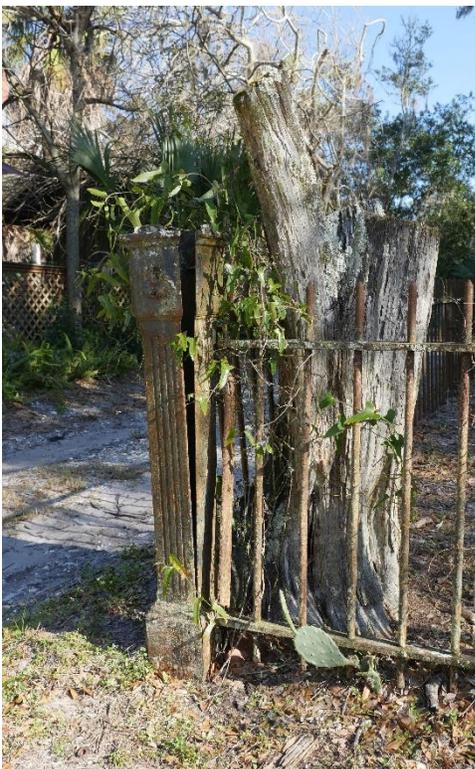
Post 2 consists of two post pieces attached to a base at ground level. The bracket for attaching the adjacent fence panel is deteriorated. The bracket on the other side that should include the gate latch hardware is missing and has been replaced by a modern pipe. The support is bent, but can possibly be straightened. Post 2 needs a cap and a finial and a circle rod and a through bolt.

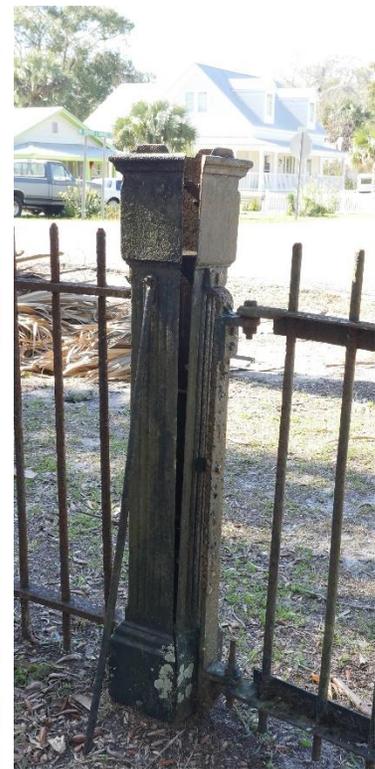
Post 3 consists of two post pieces attached at the base at ground level. The support is bent but present. The hinge bracket appears serviceable. The bottom and top brackets for attachment to the fence panel are modern repairs. Post 3 lacks a cap, a finial, a circle rod and a through bolt. Posts 2 and 3 are 5 feet apart, on center.

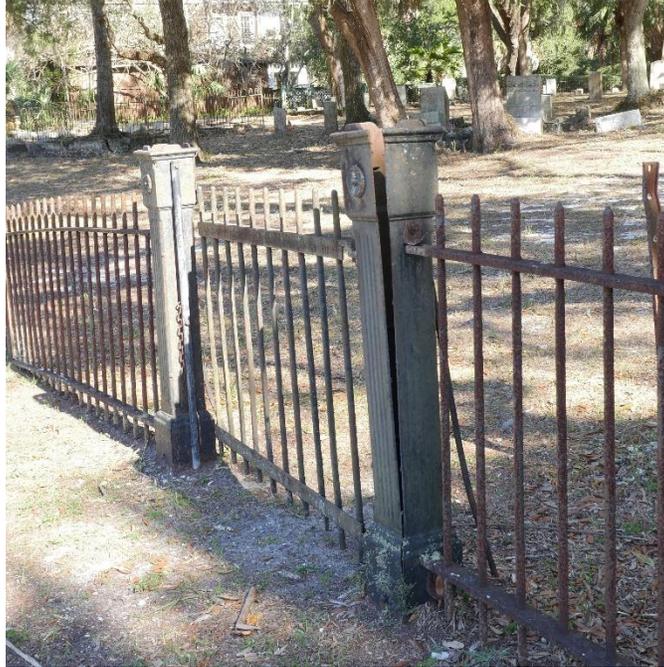
Gate 3

The Rear Gate is located between Posts 2 and 3. It is a one-piece gate made up of angle iron and patterned rebar. The length of the gate rail is 4 ft. 2 in. There are 9 rebar pickets which are attached to angle iron with a face outward. The hinge hardware is attached with a horizontal bracket to Post 3. The gate stop, in the ground on the hinge side to prevent the gate from swinging open too far, may be original. It should be measured to see if it is a piece of fence panel rail.

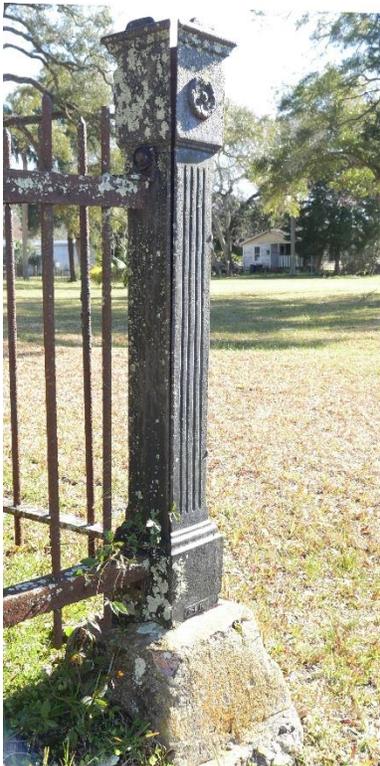
Post 4 is mounted on a concrete (and possibly brick?) foundation. Its two components are firmly attached at the bottom. The brackets for the attachment of the fence panel appear to be original with a cast corner bracket at the bottom and a flat bracket at the top. Post 4 needs a cap, a finial, a circle rod and a through bolt.

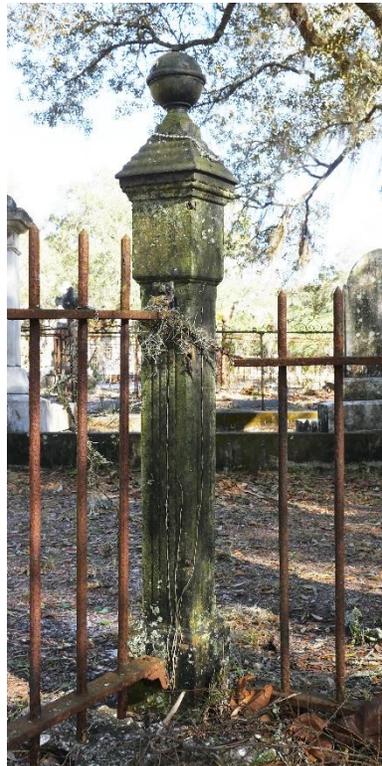
Post 5 is intact. It is mounted in concrete. The hardware for mounting panels appears to be the same as at several other posts, suggesting that vertical brackets may not have been used for all cast iron posts. The square cap and the finial and the rod are all present, although the circle is missing at the end of the rod. The through bolt is present. Brackets are missing for attachment of one fence panel, which is resting loose on the ground at the bottom rail.

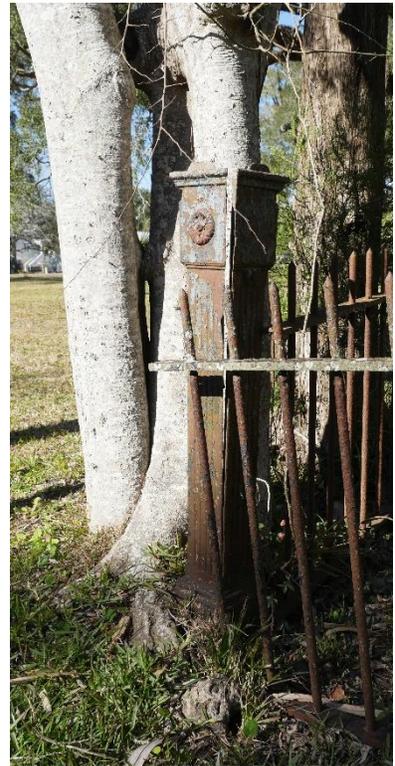
Post 6 is abutted by a tree and is missing two bar brackets that attach the panel to the post. Two fence panels southeast of this post are in poor condition. One section has been removed and leaned against the adjacent panel. Measured from Post 6 toward Post 7 they are:

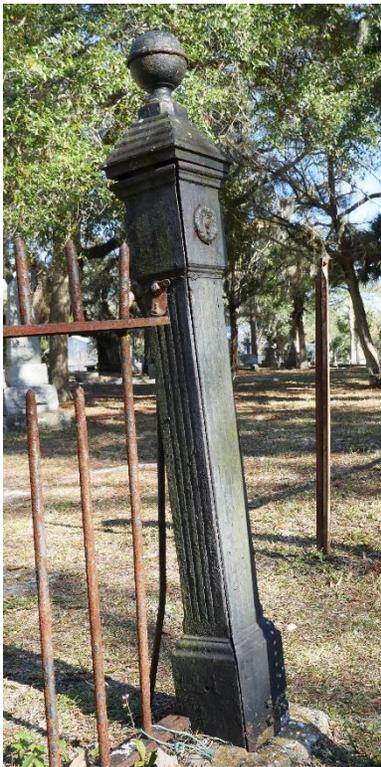
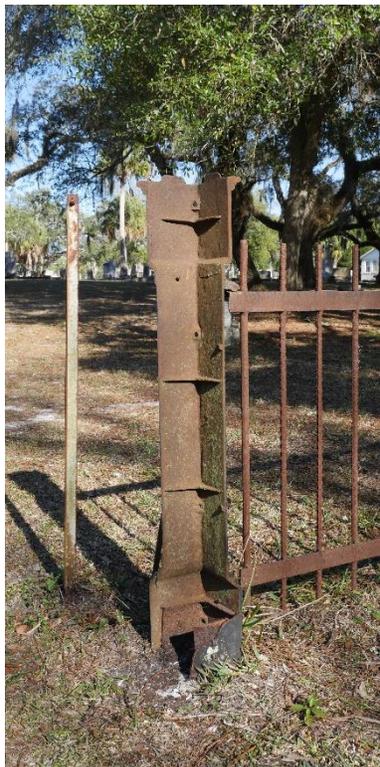
- Post 7 is missing 1 bar bracket for panel attachment and 1 hinge bracket.
- The Side Gate (Gate 2) is 4 ft. 3 in wide and is made of angle iron with 10 pickets of rebar steel. The gate is missing a closure mechanism.
- Post 8 has broken cast iron at the lower outside attachment. A single bar bracket is missing for attachment of the adjacent panel. Immediately southeast of Post 8, a small section of fence is made up of angle iron and rebar.

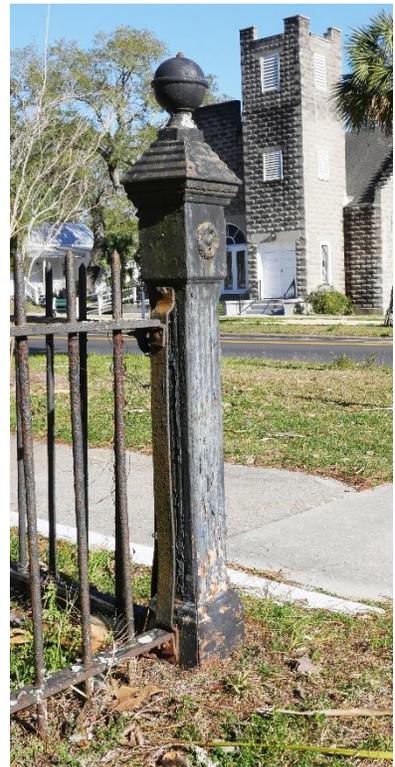
Post 9

This post is intact on its concrete foundation at the front of the cemetery at the intersection of Hwy. 98 and 8th Street.

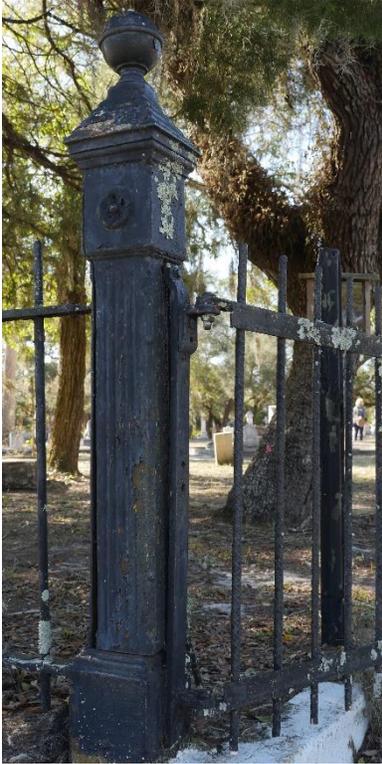
Post 10 and Front Gate (Gate 1)

- Post 10 is missing 1 bar bracket and 2 angle brackets. The hinge bracket is present and operable. Post 10 needs 1 bar bracket. The hinge bracket is present and working, but the hinge side of Post 10 is broken at the base.
- The Front Gate (Gate 1), is made from angle iron with rebar pickets.
- Post 11 needs a bar bracket to attach the panel as it originally was; the hinge bracket works properly.

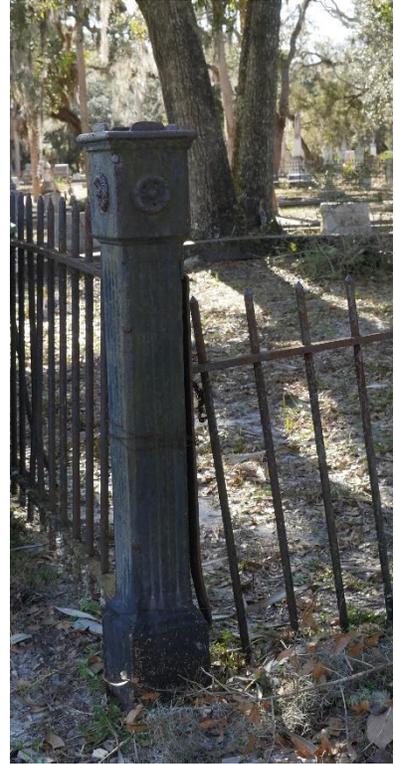
Post 12 is at the east end of the front cemetery fence along Hwy. 98. It is broken at the side panel near the top below the rosette. Two bar brackets are missing.
